St. Elizabeth's East Existing Infrastructure Condition Review Report

Prepared for
District of Columbia
Office of Deputy Mayor
For Planning & Economic Development

January 2012

CH2MHILL®

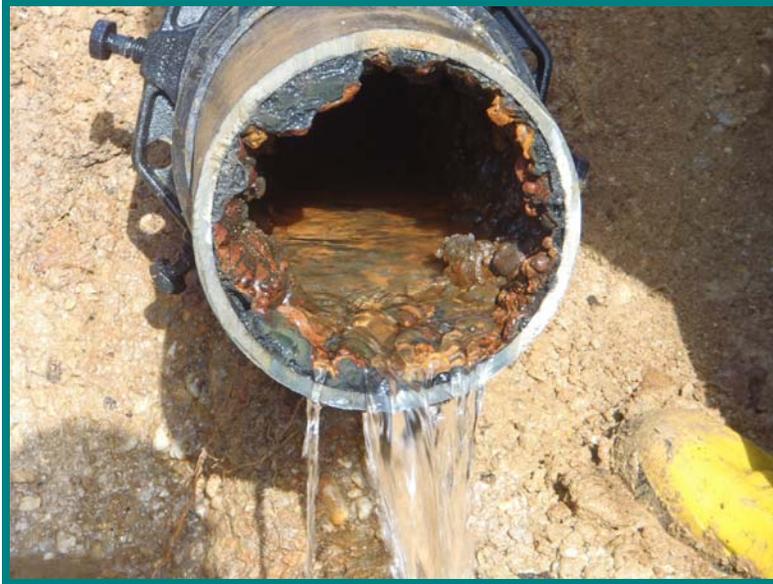
All existing water systems on East Campus are private and master metered at offsite connections by DC Water. During the construction of the new St. Elizabeths Hospital, it was noted that aging and brittle piping, valves, and hydrants, filled with tuberculation combined with neglectful maintenance, has resulted in a system unable to produce the required fire demand volume and pressure. Fire protection work was completed on the East Campus between November 2010 and August 2011 so the requirement of 750 gallons per minute (gpm) at each hydrant could be met. Pressure testing was performed and recorded for all hydrants with 100 percent compliance above 750 gpm. A 100,000-gallon private elevated tank is located on the East Campus. A map of the system improvements, the results of the hydrant testing, and pictures of typical tuberculation encountered are contained in Appendix 2.

Ex. Pipe at Tie-In Near FH #65

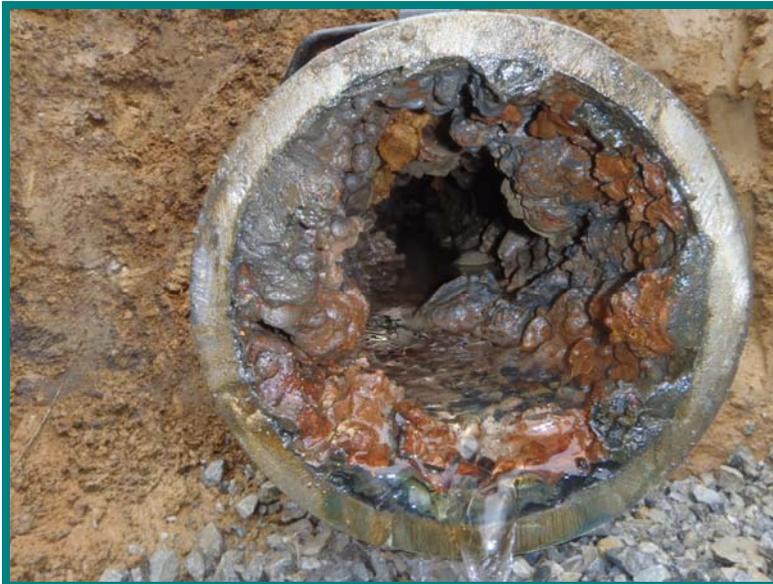
Ex. Branch Line (North) Near FH #71

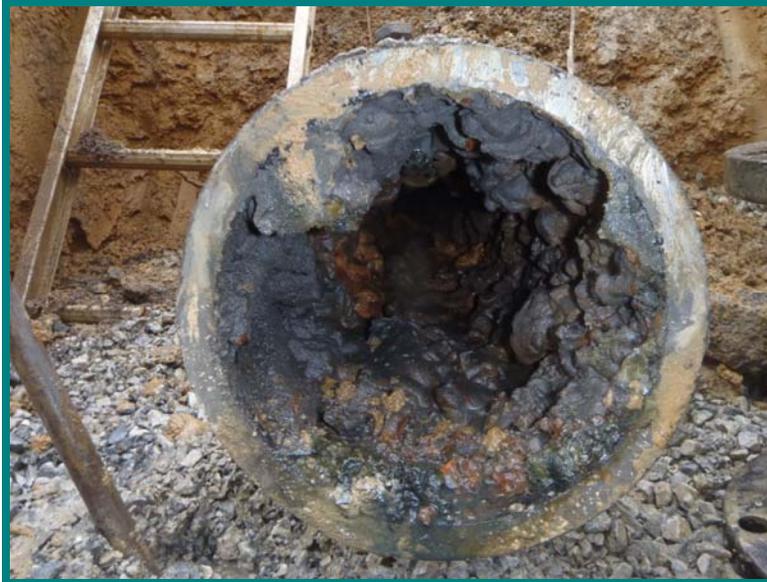
Ex. Branch Line (South) Near FH #76

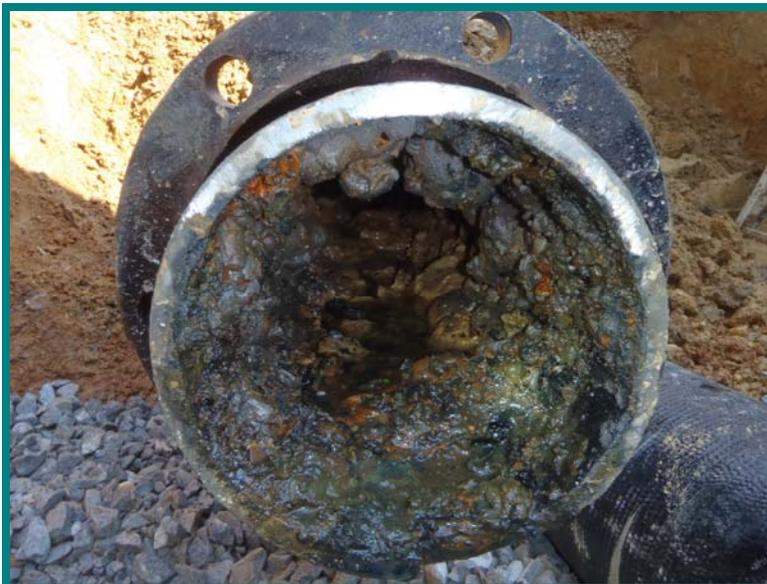
Ex. Feeder Line Near FH #96

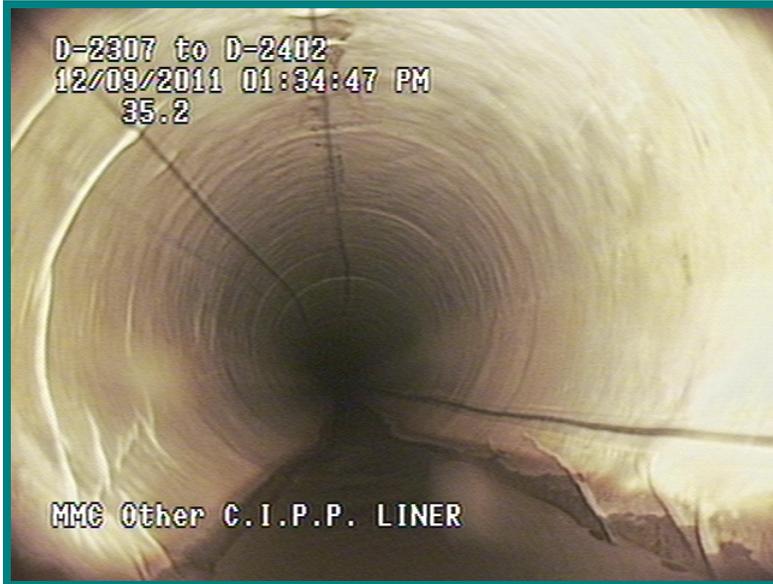
- The 42-inch reinforced concrete pipe (RCP) line segment under the hospital access road has been lined with cured-in-place pipe (CIPP), and additional manhole (doghouse) structures were incorporated for CIPP installation and connection of the hospital drainage pipes to the existing outfall line.

Pipe Segment Between D-2307 & D-2402 – CIPP Lined

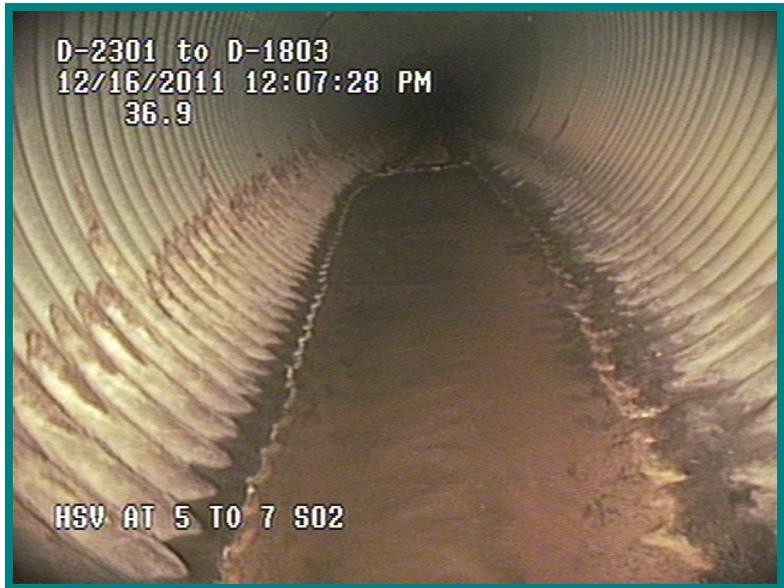
- The 42-inch segment designated as D2301 to D1803 is corrugated metal pipe (CMP) pipe. See Exhibit B, Appendix 3. This segment will likely require further evaluation with regard to rehabilitation if the system is to be incorporated with future development needs. Typical deficiencies found included missing bituminous coating and subsequent pipe deterioration along the bottom of the pipe. The pipe can be rehabilitated utilizing trenchless methods condition. Open cut repair may not be economically feasible given cover depth and vicinity proximity to Metro Transit Authority ventilation shaft

Pipe Segment Between D-2301 & D-1803 - CMP

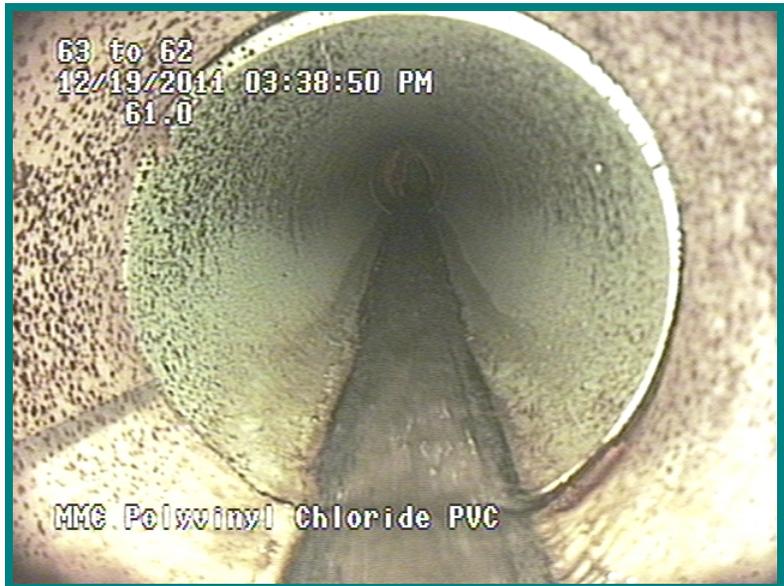
Pipe Segment Between 63 & 62 - PVC

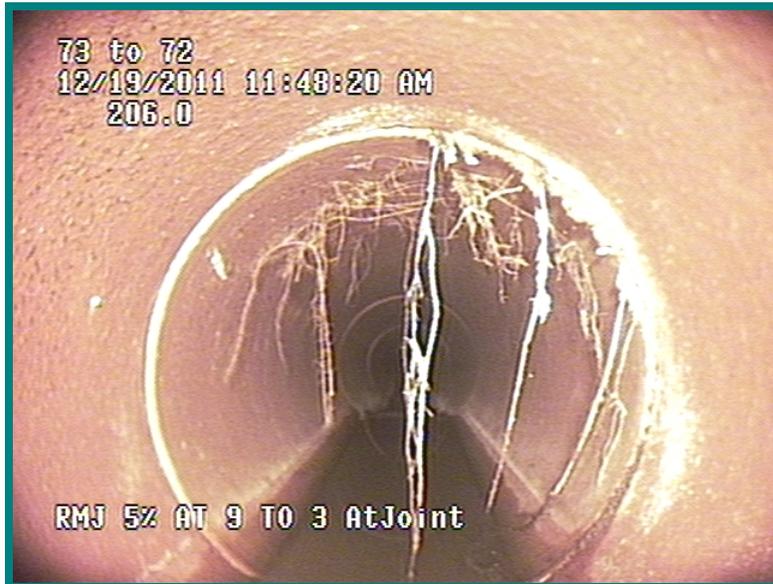
- The trunk system inspected was constructed in the early 1970's to replace an older system.
- Given the age of the vitrified clay pipe (VCP): the system is in acceptable operational condition.
- As anticipated, there are root issues, location specific structural deficiencies and varying degrees of joint infiltration.
- The access (manhole) structures observed to date are generally structurally sound; however will need rehabilitation if continued future use is desired.

Pipe Segment Between 73 & 72 – Root Damage
