14. Description of amendment/modification (Organized by UCF Section headings, including solicitation/contract subject matter where feasible.)				
<p>Caption: Renovation of 107 & 117 Wayne Place, S.E.</p> <p>Add the following to Section J "List of Attachments"</p> <p>1. Attachment J.15 - Limited Hazardous Materials Survey Report for 107 Wayne Place, S.E. 2. Attachment J.16 - Limited Hazardous Materials Survey Report for 117 Wayne Place, S.E.</p> <p>The opening date for receipt of bids, time and place remains the same.</p>				
Except as provided herein, all terms and conditions of the document referenced in Item (9A or 10A) remain unchanged and in full force and effect				
15A. Name and Title of Signer (Type or print)			16A. Name of Contracting Officer Diane Wooden	
15B. Name of Contractor		15C. Date Signed	16B. District of Columbia <i>Diane Wooden</i>	16C. Date Signed <i>11/11/11</i>
(Signature of person authorized to sign)			(Signature of Contracting Officer)

LIMITED HAZARDOUS MATERIALS SURVEY REPORT

As authorized by Atelier Architects, P.L.L.C. (Client), Froehling & Robertson, Inc. (F&R) personnel performed a limited non-invasive hazardous materials survey of 107 Wayne Place, SE

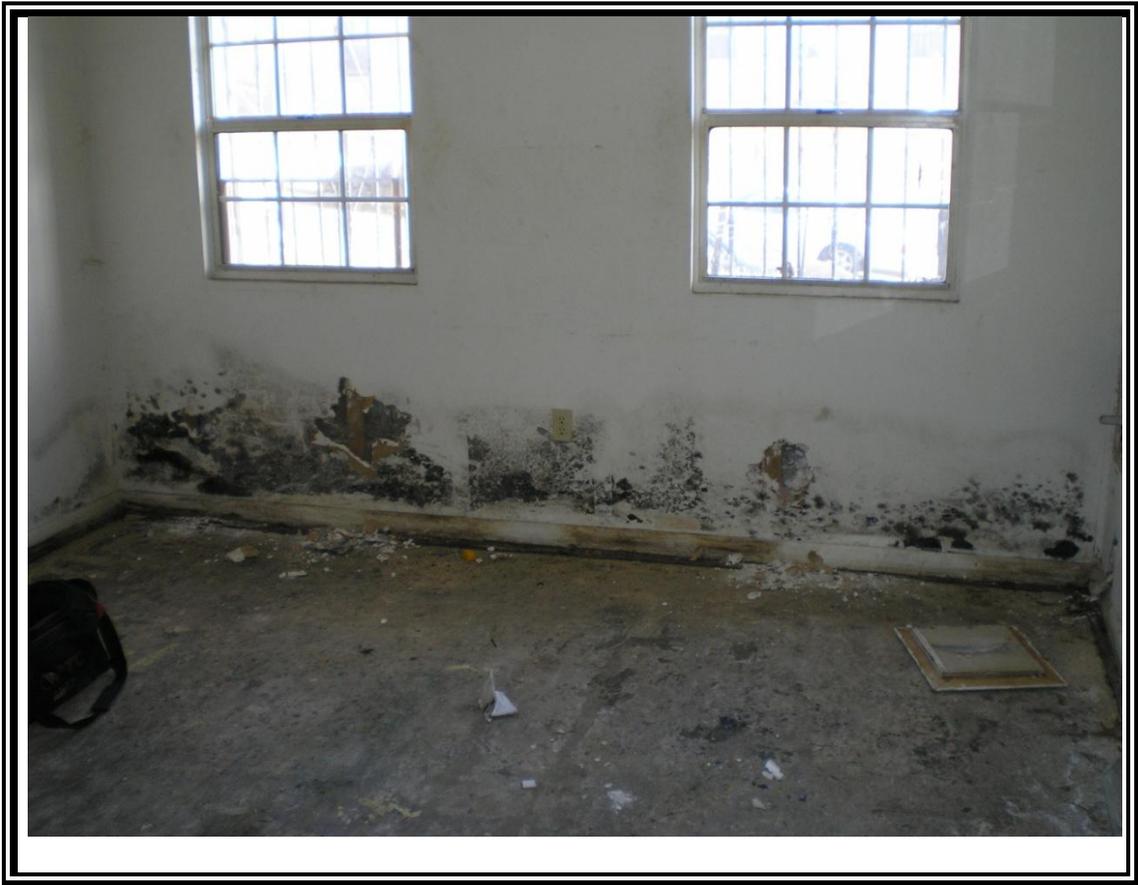
- Mold was observed on the bottom 3’ of the sheetrock walls throughout the living room, dining room and kitchen. This mold growth was also observed on the wood studs underneath. “Wet” moisture readings were recorded on the sheetrock walls; however, the wood studs recorded “dry” readings.
- Mold was observed on 10 square feet of the sheetrock walls in the bedroom. No mold growth was observed on the wood studs underneath. “Dry” moisture meter readings were recorded in this area.
- Mold was observed on the bottom 1’ of sheetrock walls in the bathroom. No mold growth was observed on the wood studs underneath. “Wet” moisture readings were recorded on the sheetrock wall and ceiling.

1. View of mold growth on sheetrock walls in 1st Floor South Side Apartment Living Room.

- a) Based upon our observations, F&R recommends drying/mold remediation of all impacted areas by a qualified contractor prior to tenant occupancy and installation of new finishes. F&R also recommends consultation with a qualified building engineer to identify and correct all potential moisture intrusion sources into the building.

- d) F&R recommends removal of sheetrock and insulation (if present) four feet up all of the walls in impacted areas. The Contractor should have a Protimeter or similar meter to verify that all wet/moist sheetrock is removed as part of this process. Mold present on solid wood surfaces such as wood framing and floors may require sanding of the surface along with application of a wide-acting antimicrobial agent. This will need to be evaluated during the remediation by a qualified contractor or engineer. Metal/PVC pipes and support structures should be cleaned and decontaminated by damp-wiping, HEPA vacuuming and brushing.

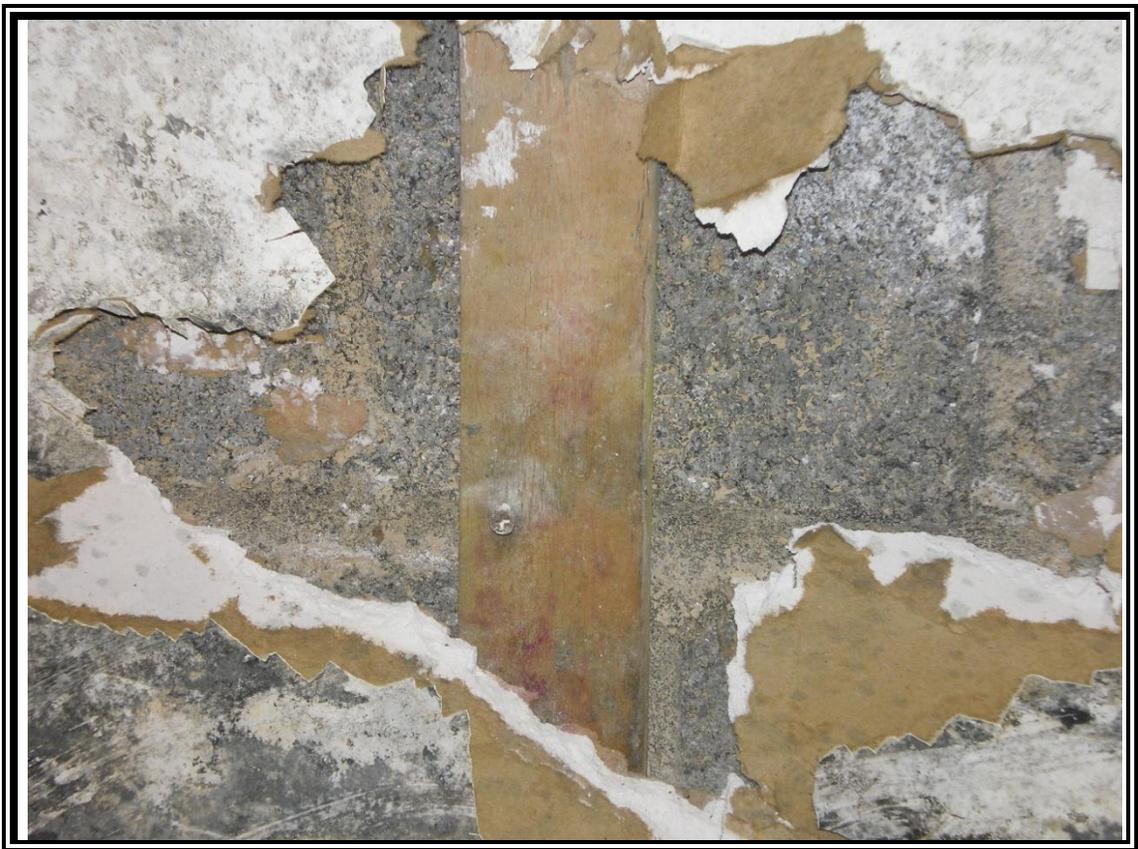
2. View of mold growth on sheetrock walls and wood wall studs in 1st Floor South Side Apartment Living Room.

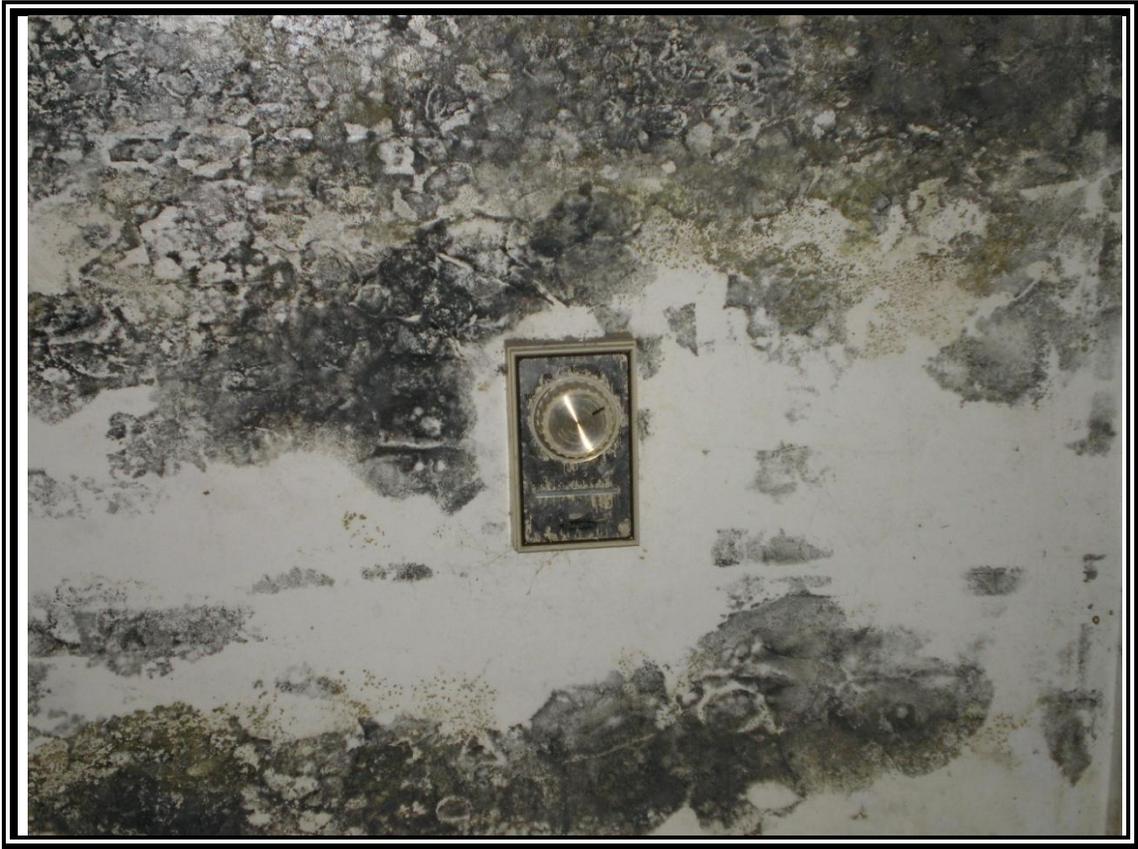
During this survey, F&R personnel observed one (1) presumed mercury-containing thermostat in the laundry room. No fluorescent lamps were observed at the site.

- Mold was observed on the bottom 4’ of sheetrock walls throughout the laundry room. This mold growth was also observed on the wood wall studs underneath. “Wet” moisture readings were recorded on the walls, ceiling and wall studs.
- Mold growth was observed on the wood ceiling joists in the southwest back room. “Wet” moisture readings were recorded on the ceiling joists in this area.

3. View of thermostat with mercury switches and mold growth on sheetrock walls in the Laundry Room.

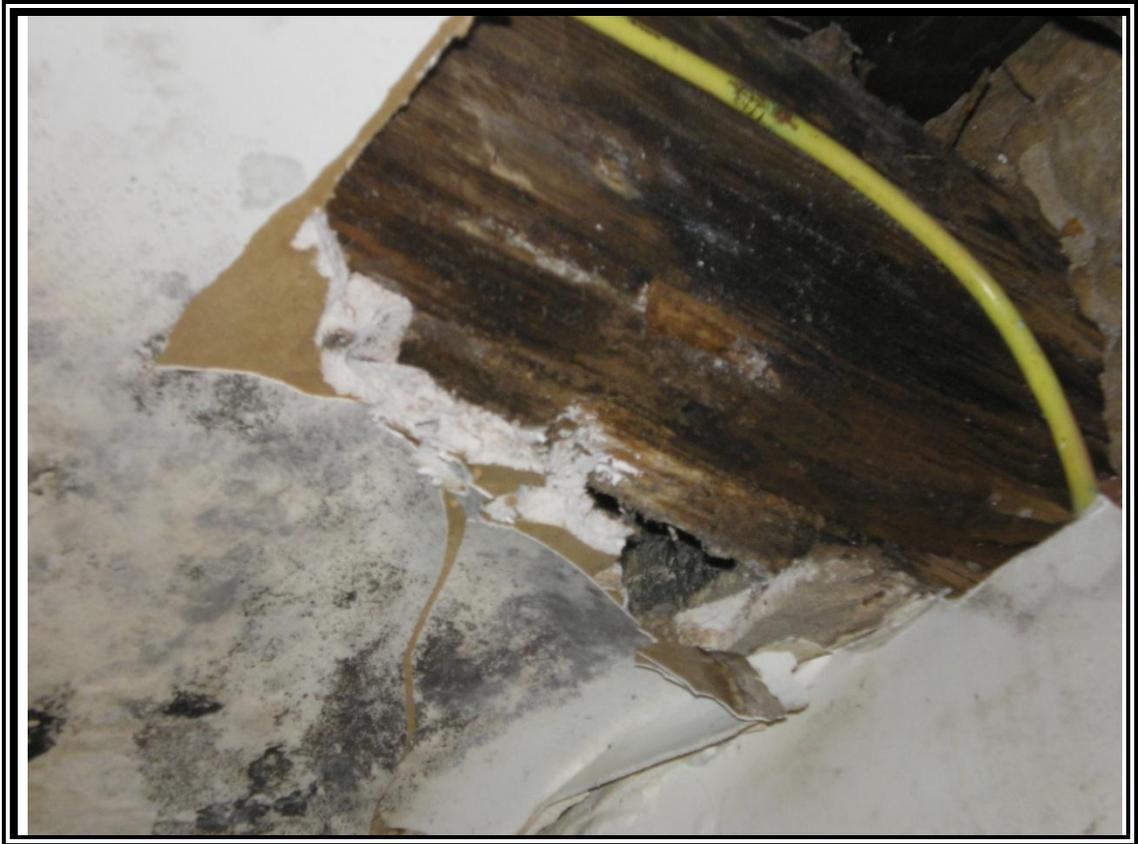
4. View of mold growth on sheetrock ceiling and wood ceiling joists in the Laundry Room.

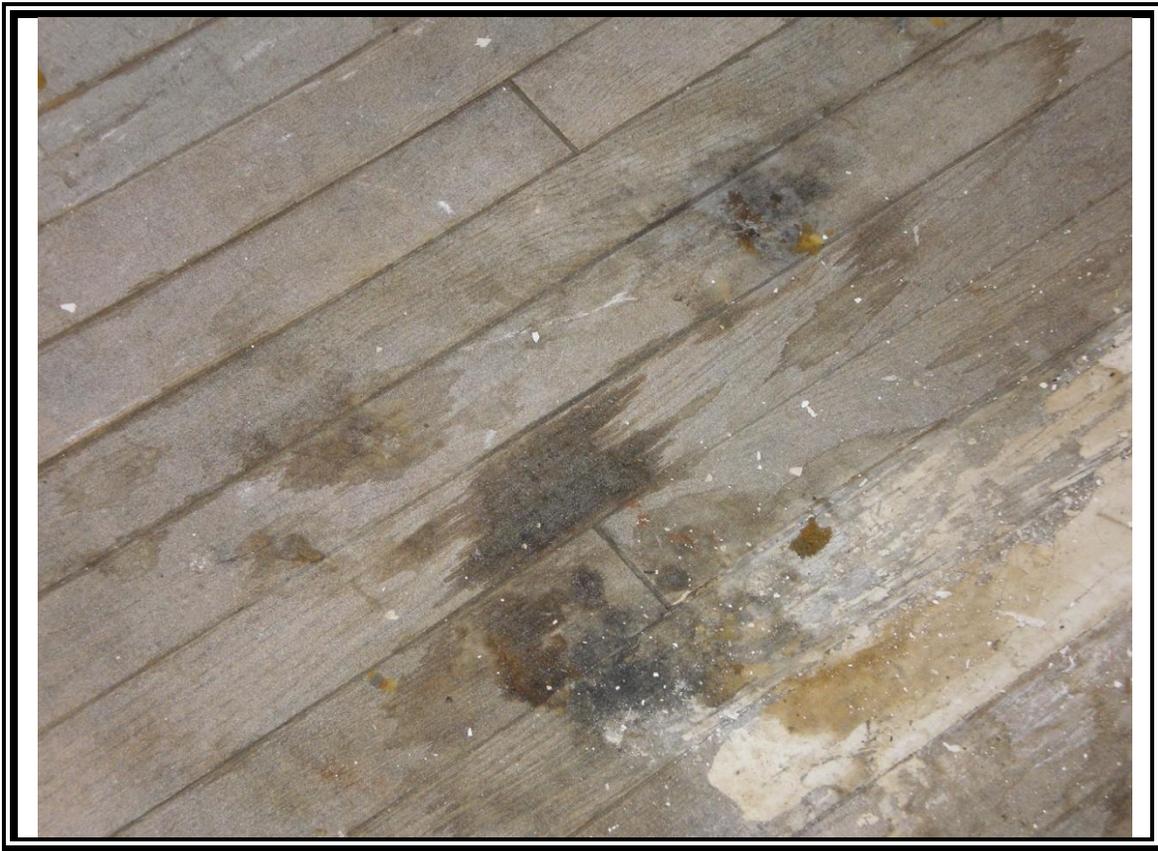
5. View of mold growth on wood floors in 2nd Floor South Side Apartment Bedroom.

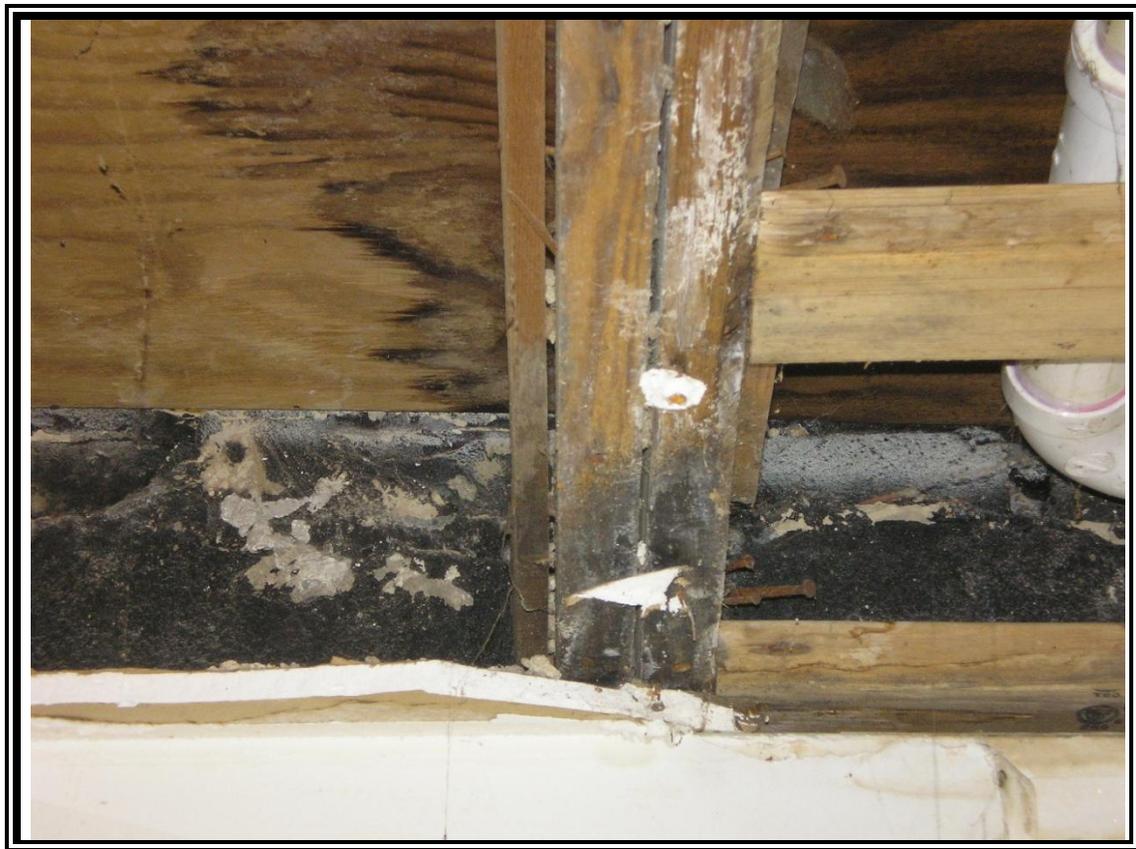
6. View of mold growth on ceiling joists in 2nd Floor South Side Apartment Bathroom.

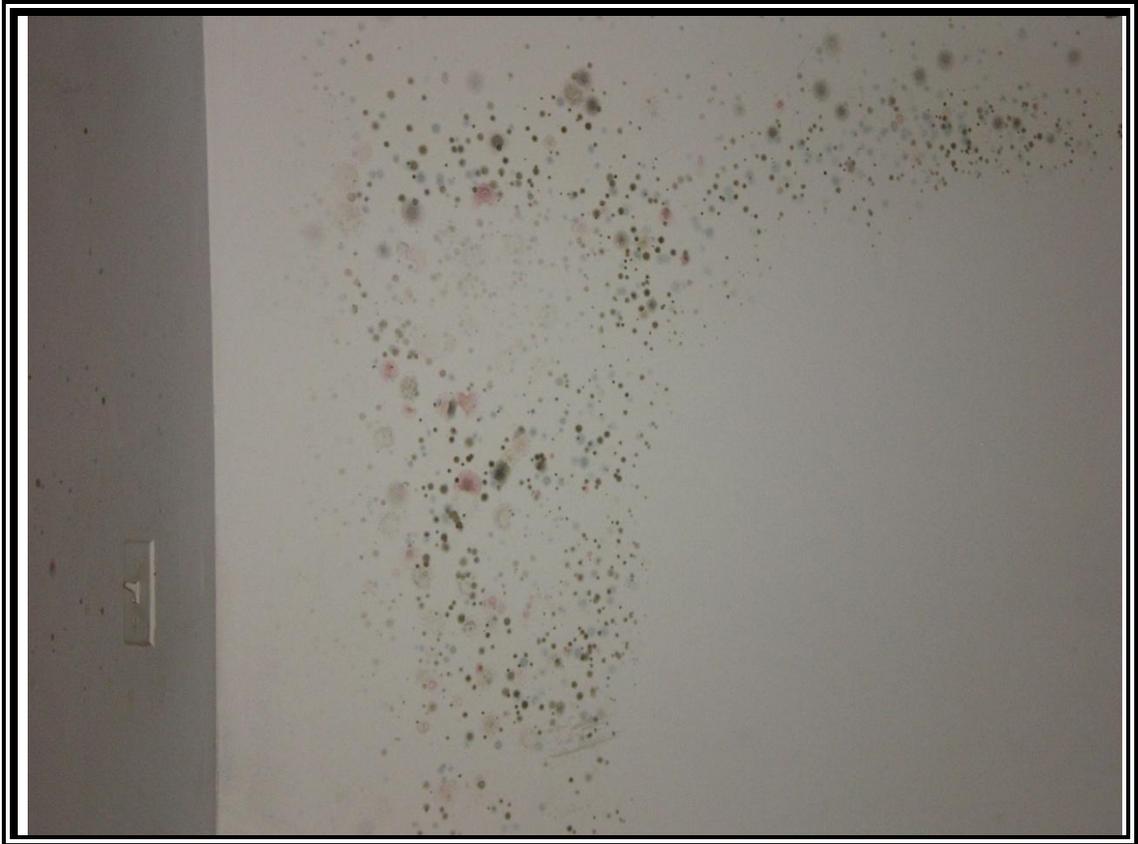
8. View of mold growth on sheetrock wall in 2nd Floor South Side Apartment Hallway.

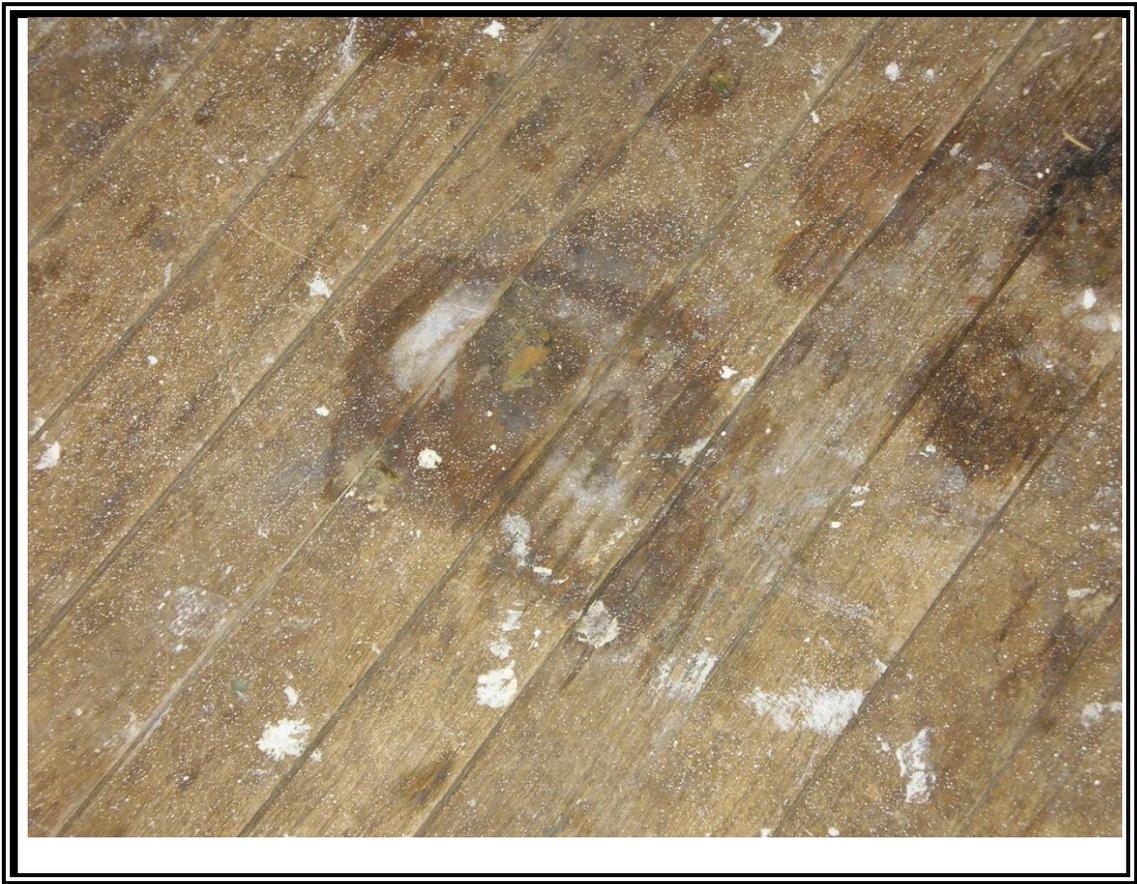
1. View of mold growth on wood floor in 1st Floor South Side Apartment.

- a) Based upon our observations, F&R recommends drying/mold remediation of all impacted areas by a qualified contractor prior to tenant occupancy and installation of new finishes. F&R also recommends consultation with a qualified building engineer to identify and correct all potential moisture intrusion sources into the building.
- b) F&R recommends that remediation activities be performed in general accordance with the guidelines described in EPA's March 2001 document "Mold Remediation in Schools and Commercial Buildings". Due to the visible fungal growth and/or moisture damage in the affected areas and widespread nature of the contamination observed, F&R recommends following the procedures given in Table 2: "Guidelines for Remediating Building Materials with Mold Growth Caused by Clean Water" for large areas greater than 100 square feet.

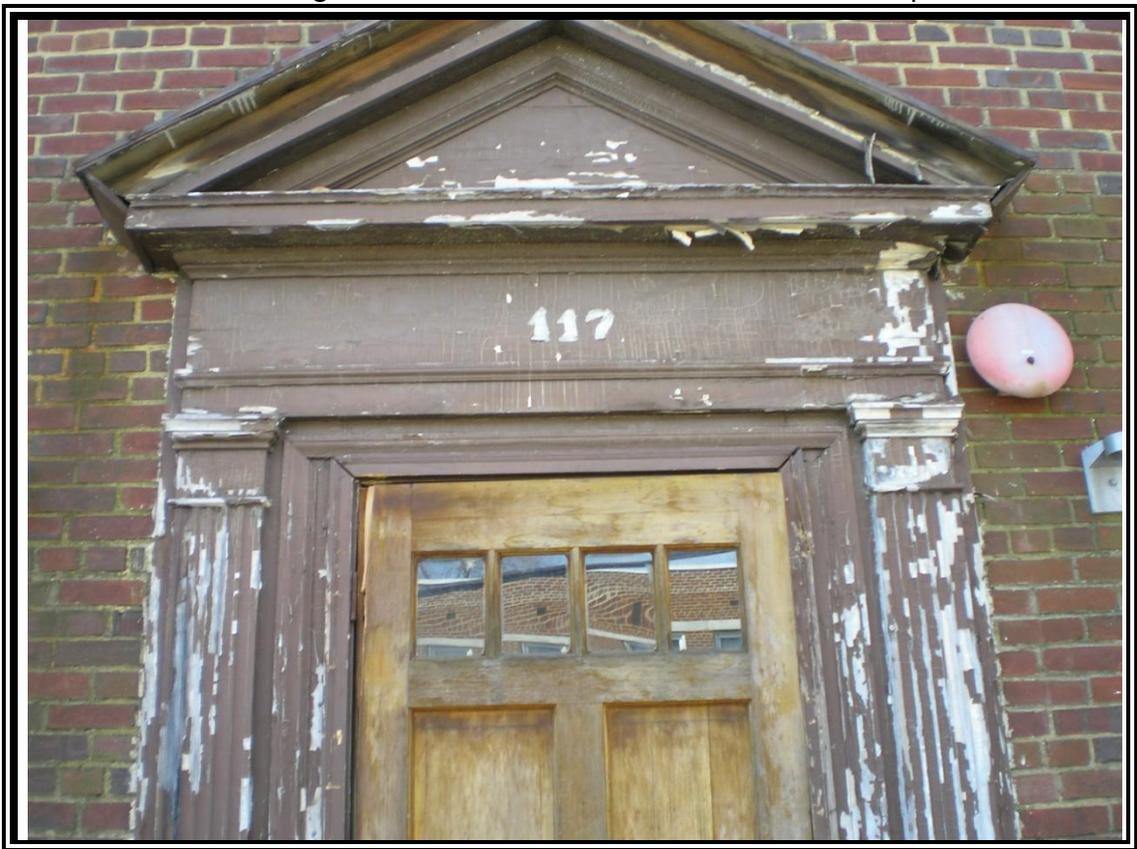
2. View of exterior brown wood door frame with lead-based paint.

It is important to note that OSHA, under its Lead in Construction standard (29 CFR 1926.62, Paragraph d), does not define acceptable levels of lead in paint at which no exposure to airborne lead (above the action level) would be expected. Rather, OSHA defines airborne concentrations, and references specific types of work practices and operations from which a lead hazard may be generated. Environmental and personnel monitoring should be conducted during any removal/demolition process (as appropriate) to verify that actual personal exposures are below the Permissible Exposure Limit (PEL). Under OSHA requirements, the contractor performing the work will be required to conduct this monitoring and follow all of the other requirements found under 29 CFR 1926.62. Based on the findings of this survey, F&R recommends that all painted surfaces be assumed to contain LBP or lead-containing paint.

In accordance with the *District of Columbia Lead-Based Paint Abatement and Control Act of 1996* and the EPA and HUD *Residential Lead-Based Paint Hazard Reduction Act of 1992 (Title X)*, a lead-based paint inspection and risk assessment should be conducted according to EPA/HUD and District of Columbia protocols by a District of Columbia licensed Lead Risk Assessor prior to occupancy of the building by children under the age of 8. If the lead-based paint inspection and risk assessment shows that lead-based paint hazards exist at the site, than a lead-based paint management plan should be prepared and implemented by a District of Columbia licensed Lead Risk Assessor.

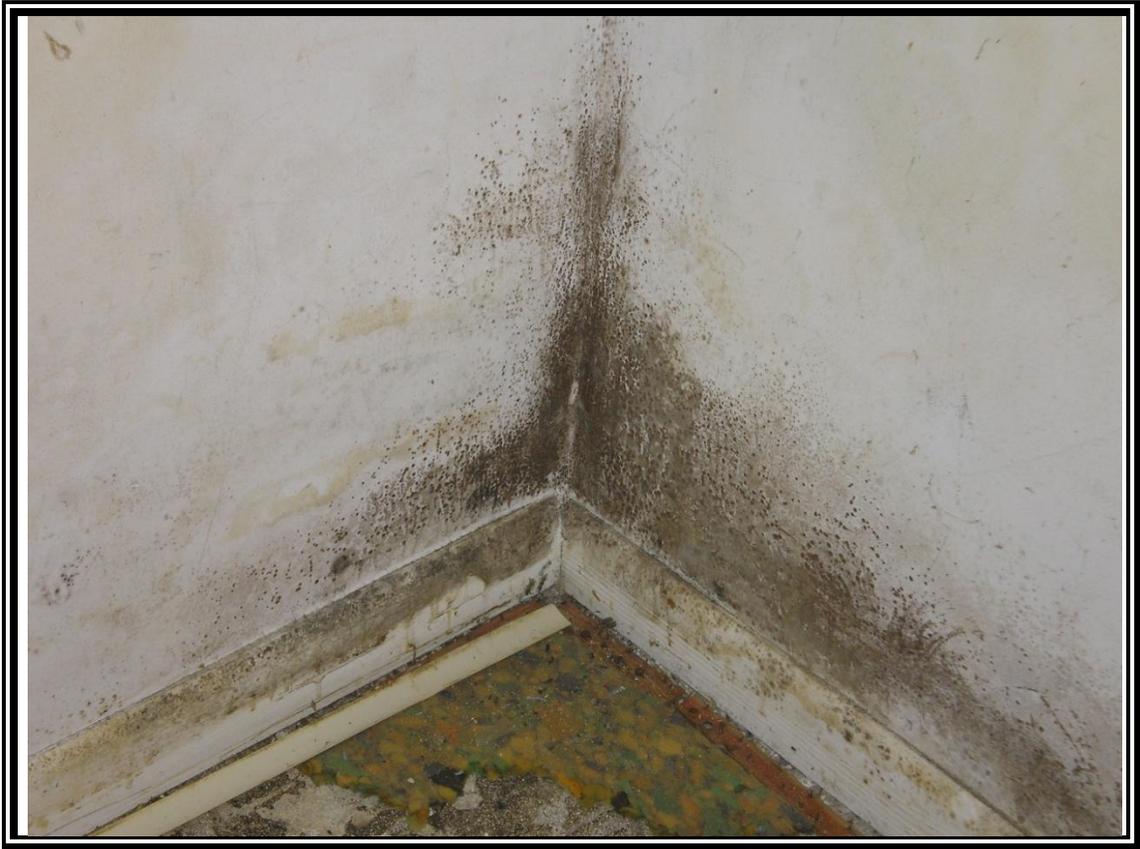
3. View of mold growth on sheetrock wall in 1st Floor North Side Apartment Living Room.

- d) F&R recommends removal of sheetrock and insulation (if present) four feet up all of the walls in impacted areas. The Contractor should have a Protimeter or similar meter to verify that all wet/moist sheetrock is removed as part of this process. Mold present on solid wood surfaces such as wood framing and floors may require sanding of the surface along with application of a wide-acting antimicrobial agent. This will need to be evaluated during the remediation by a qualified contractor or engineer. Metal/PVC pipes and support structures should be cleaned and decontaminated by damp-wiping, HEPA vacuuming and brushing.

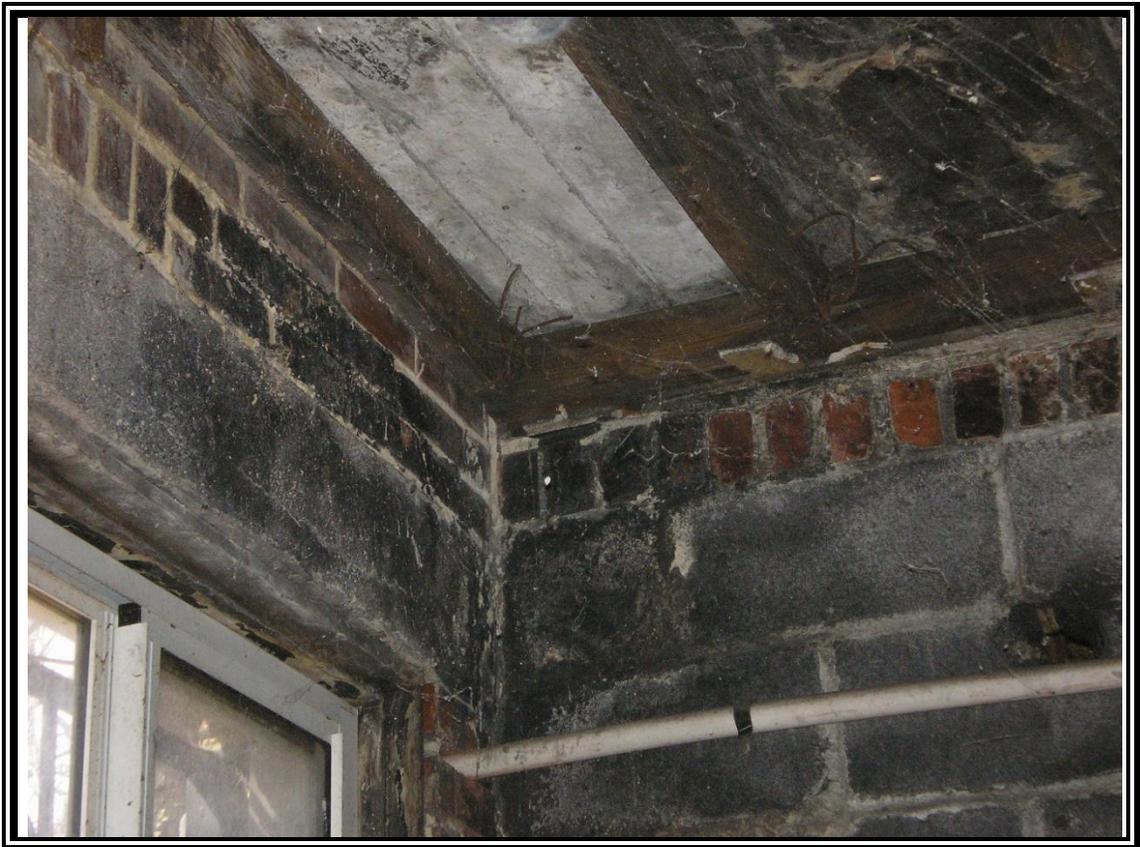
4. View of mold growth on wood ceiling joists in Basement Storage Room.

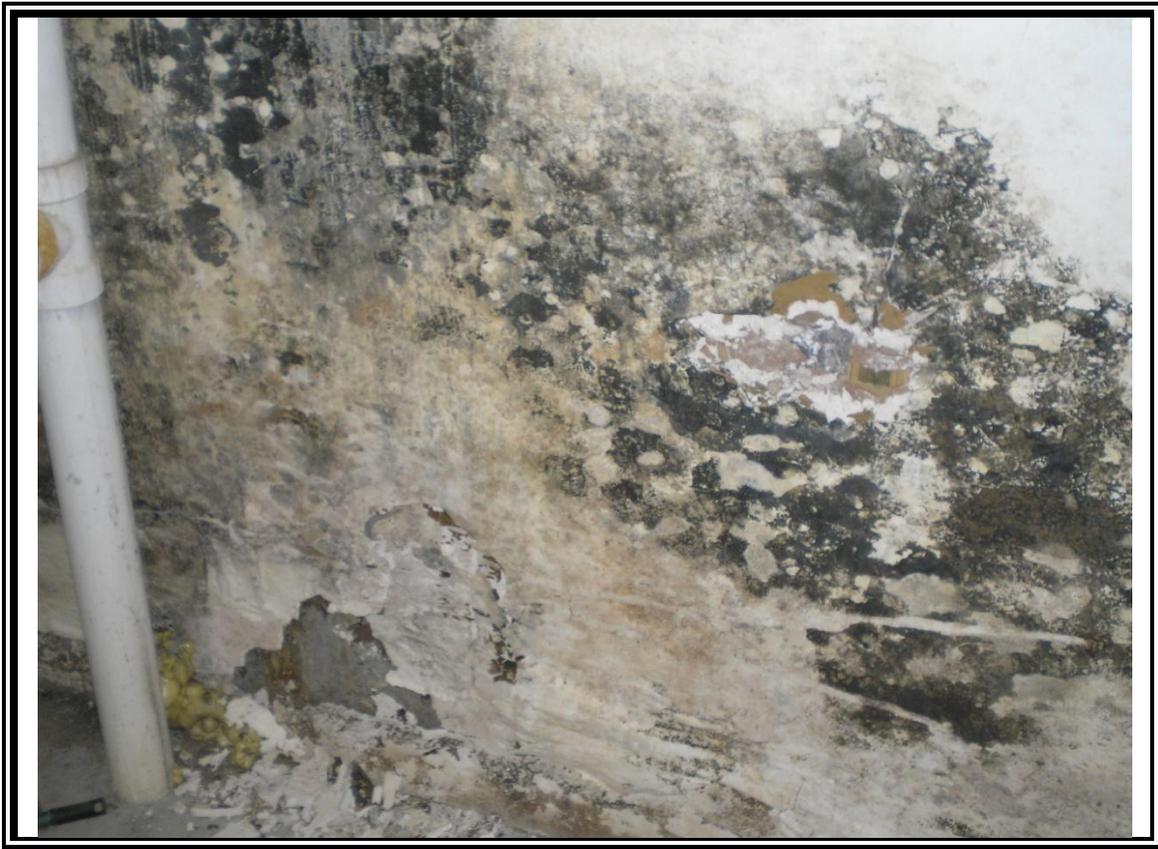
- Mold was observed on the bottom 4' of sheetrock walls as well as the sheetrock ceiling throughout the laundry room. This mold growth was also observed on the wood wall studs. "Wet" moisture readings were recorded on the walls and ceiling in this area.

5. View of mold growth on sheetrock walls in the Laundry Room.
