<b>AMENDMENT OF SOLICITATION/MODIFICATION OF CONTRACT</b>			1. Contract Number	Page of Pages	
2. Amendment/Modification Number		3. Effective Date	4. Requisition/Purchase Request No.	1	132
GF-2011-R-0030-005		October 21, 2011		5. Solicitation Caption Construction of New Student Center at UDC, Van Ness Campus

14. Description of amendment/modification (Organized by UCF Section headings, including solicitation/contract subject matter where feasible.)					
Solicitation No. GF-2011-R-0030 for Construction of New Student Center at UDC, Van Ness Campus is hereby amended as follows:

### PHASE I ENVIRONMENTAL SITE ASSESSMENT

Project Name: University of the District of Columbia

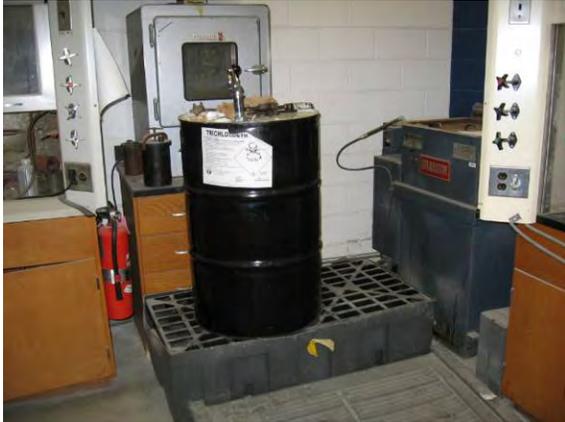
Photo #19: Waste TCE in 55-gallon drum with secondary containment in Building 42

- The Project generates hazardous waste in the form of PCBs, waste trichloethylene, waste oxidizing liquids, waste corrosive liquids, waste flammable liquids, waste toxic organic liquids, waste toxic organic solids, and florescent light tubes, medical waste in the form of bio-hazardous media and sharps, and regulated waste in the form of refrigerants and spent x-ray and photograph developer and fixer, as well as non-hazardous solid and liquid wastes, including cooking grease. Generated wastes appear to be stored and disposed of properly; with the exception of spent film developing chemicals (e.g., developers, stabilizers, bleaches, and film fixer) that are not run through a silver recovery system before they are discharged to the public sewer system. According to Ms. Tamiko Bryant, the Project does not currently have a permit for this activity. EMG recommends that waste materials be handled according to appropriate industry standards and all applicable federal, state, and local regulations.

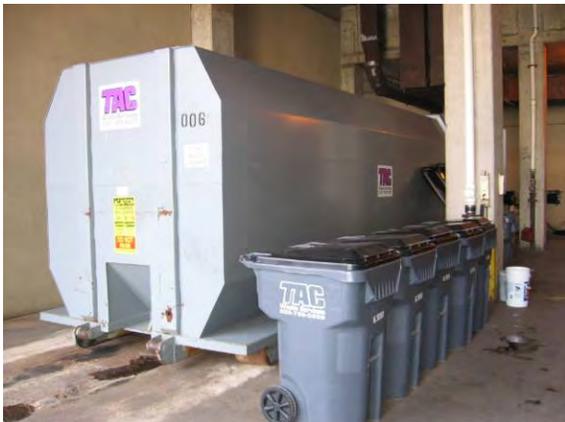
Photo #23: Hydraulic trash compactor at Building 38

- A hydraulic trash compactor is located at the Project. PCB-containing hydraulic fluid has not been manufactured since 1977. Therefore, based on the date of installation, PCB-containing hydraulic fluid is not likely to be found in the operating system. No visual indication of leakage was observed in the area of the equipment. No further action or investigation is recommended regarding the trash compactor at the Project.

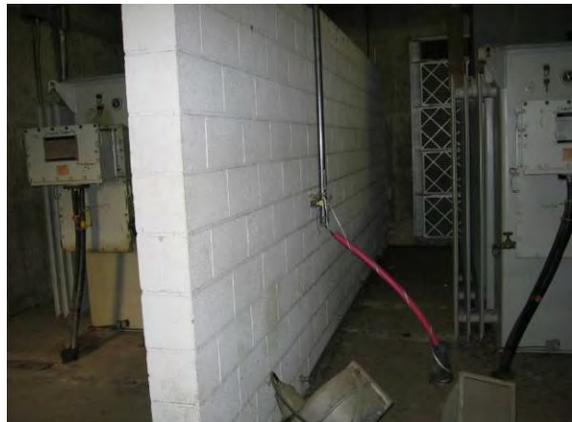
Photo #24: Utility-owned transformers in interior electrical vaults in each building

- EMG identified utility-owned transformers which are not classified regarding PCB content. This equipment appeared to be in good condition with no evidence of leaks. The utility is the financially responsible party for maintenance of the transformers. No further action or investigation is recommended regarding the transformers at the Project.

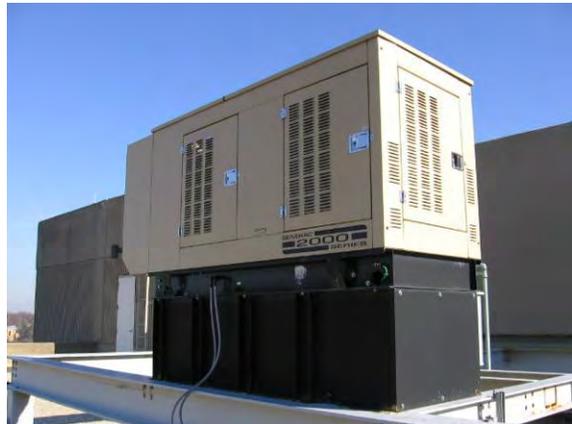
Photo #28: Homeland Security rooftop diesel belly tank for emergency generator on Building 41

- In addition, Building 41 has a rooftop emergency generator with a 200-gallon diesel belly tank and connection to the 250-gallon diesel aboveground storage tank (AST) located in the B level of the parking garage. Building 39 has a rooftop emergency generator with a diesel day tank, which are both reported to be out of use. Building 43 has an emergency generator located on the northwestern corner of the interior of level C with a 250-gallon fuel oil day tank and connections to the two exterior 8,000-gallon fuel oil ASTs. No visual structural concerns, stainage or visible evidence of leakage was observed. Furthermore, Project personnel were unaware of any releases from the tanks. Based on absence of reported releases and visual observations on the date of the assessment, the presence of the ASTs associated with the emergency generators is not anticipated to have an adverse impact on the environmental integrity of the Project.

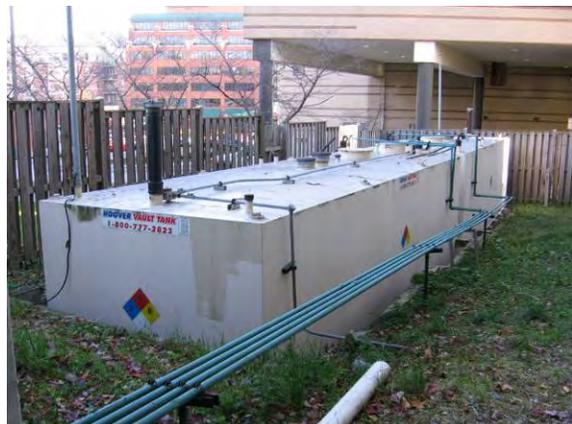
Photo #30: Two 8,000-gallon fuel oil ASTs (and former location of three 30,000-gallon USTs)

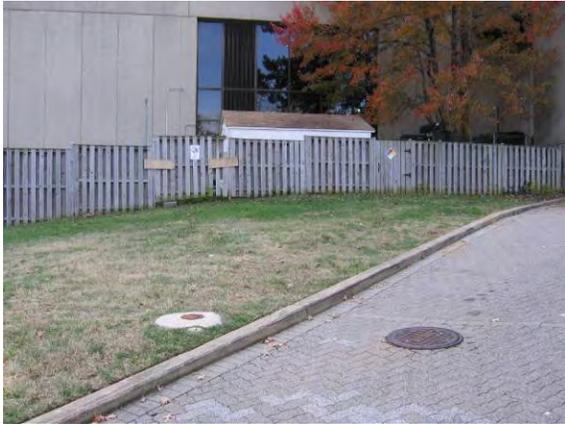
Photo #33: One of eight ground water monitoring wells located north of Building 43

- (2) EMG recommends continued groundwater sampling and laboratory analysis in accordance with applicable regulations and requirements in order to achieve regulatory closure.

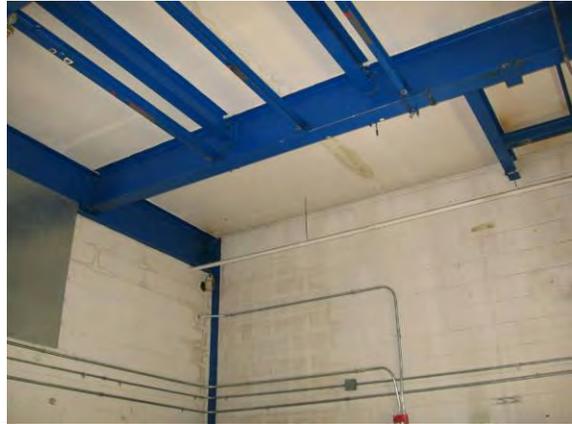
Photo #34: Water damaged painted dry wall in break room of Building 43

- Approximately two square feet of water damaged painted drywall ceiling and ten square feet of water damaged painted concrete masonry walls in the break room of the Building 43 C level. Mr. Emanuel Yeoman was unaware of the cause of the water damage.

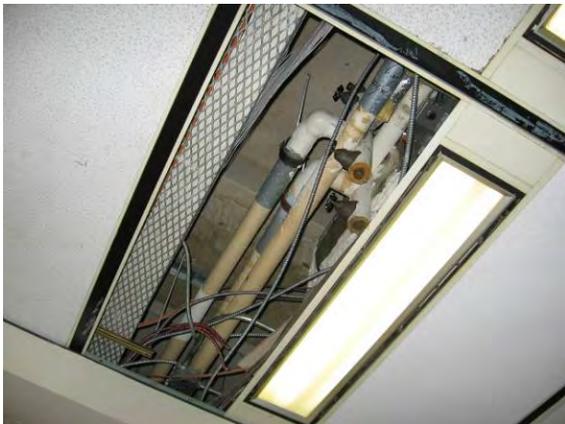
Photo #35: Water damaged ceiling tile in Building 32

- According to Mr. Emanuel Yeoman, there is a window leak that floods Room 114B of Building 42 when there is a heavy rain.
- Approximately 16 square feet of ceiling tile was removed from the women's room on Level C of Building 32 due to water damage from a burst pipe on the B level in December of 2008.

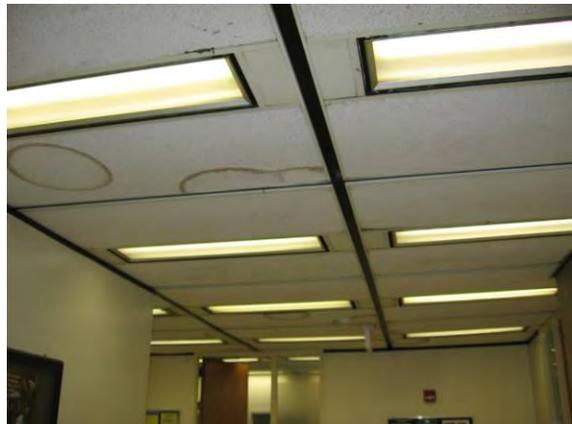
Photo #36: Water damaged ceiling tile in Buildings 38 and 39

- Water staining on the concrete in the stairwells of Building 38 and Building 39 was reportedly caused by leaking sky lights. According to Mr. Emanuel Yeoman, these leaks have been repaired.

- Approximately 15 square feet of water stained ceiling tile was observed in the women's room on the first floor of Building 38. Approximately 20 square feet of water damaged ceiling tile was observed in Room 108 and the first level hallways of Building 38. Approximately five square feet of water damaged ceiling tile was observed in A10 and A14 of Building 38. Approximately 10 square feet of water damaged ceiling tile was observed on the first floor of Building 39. According to Mr. Emanuel Yeoman, the damage was caused from a former leak on the second floor from an open valve that flooded the buildings.

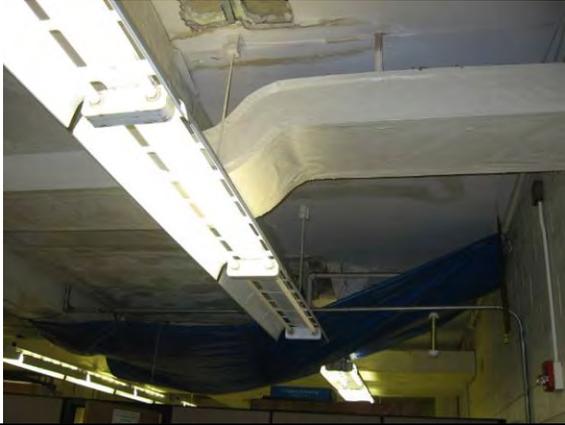
Photo #37: Water damaged painted drywall ceiling in the Building 39 copy room

- According to Mr. Emanuel Yeoman, there is a window leak that floods Room 103 of Building 38 when there is a heavy rain.
- Approximately 50 square feet of water damaged painted drywall ceiling in the copy room on level C of Building 39. According to Mr. Emanuel Yeoman, this damage was caused by the leaking expansion joint above the area.

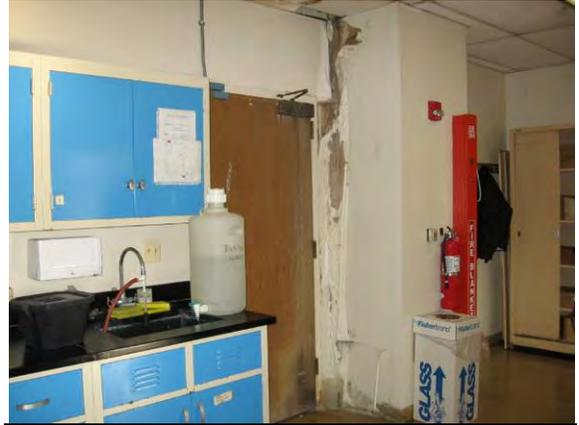
Photo #38: Water damaged ceiling tiles, drywall, and floor tiles in Building 44 Room 311

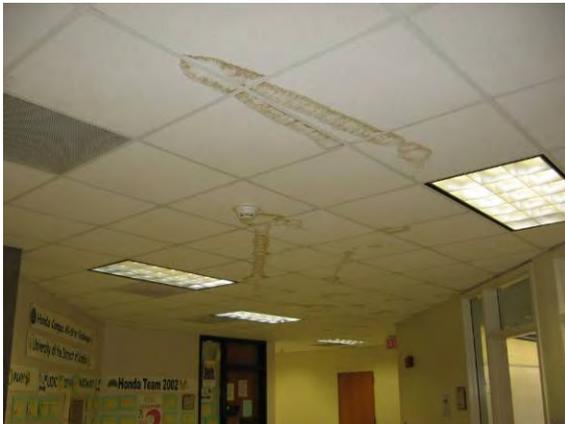
Photo #39: Significant water damage throughout Building 41

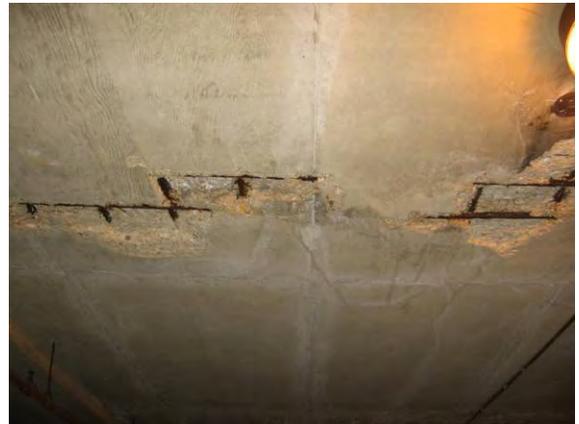
Photo #40: Significant water damage throughout the parking garage
