St. Elizabeth's East Existing Infrastructure Condition Review Report

Prepared for
District of Columbia
Office of Deputy Mayor
For Planning & Economic Development

January 2012

CH2MHILL®

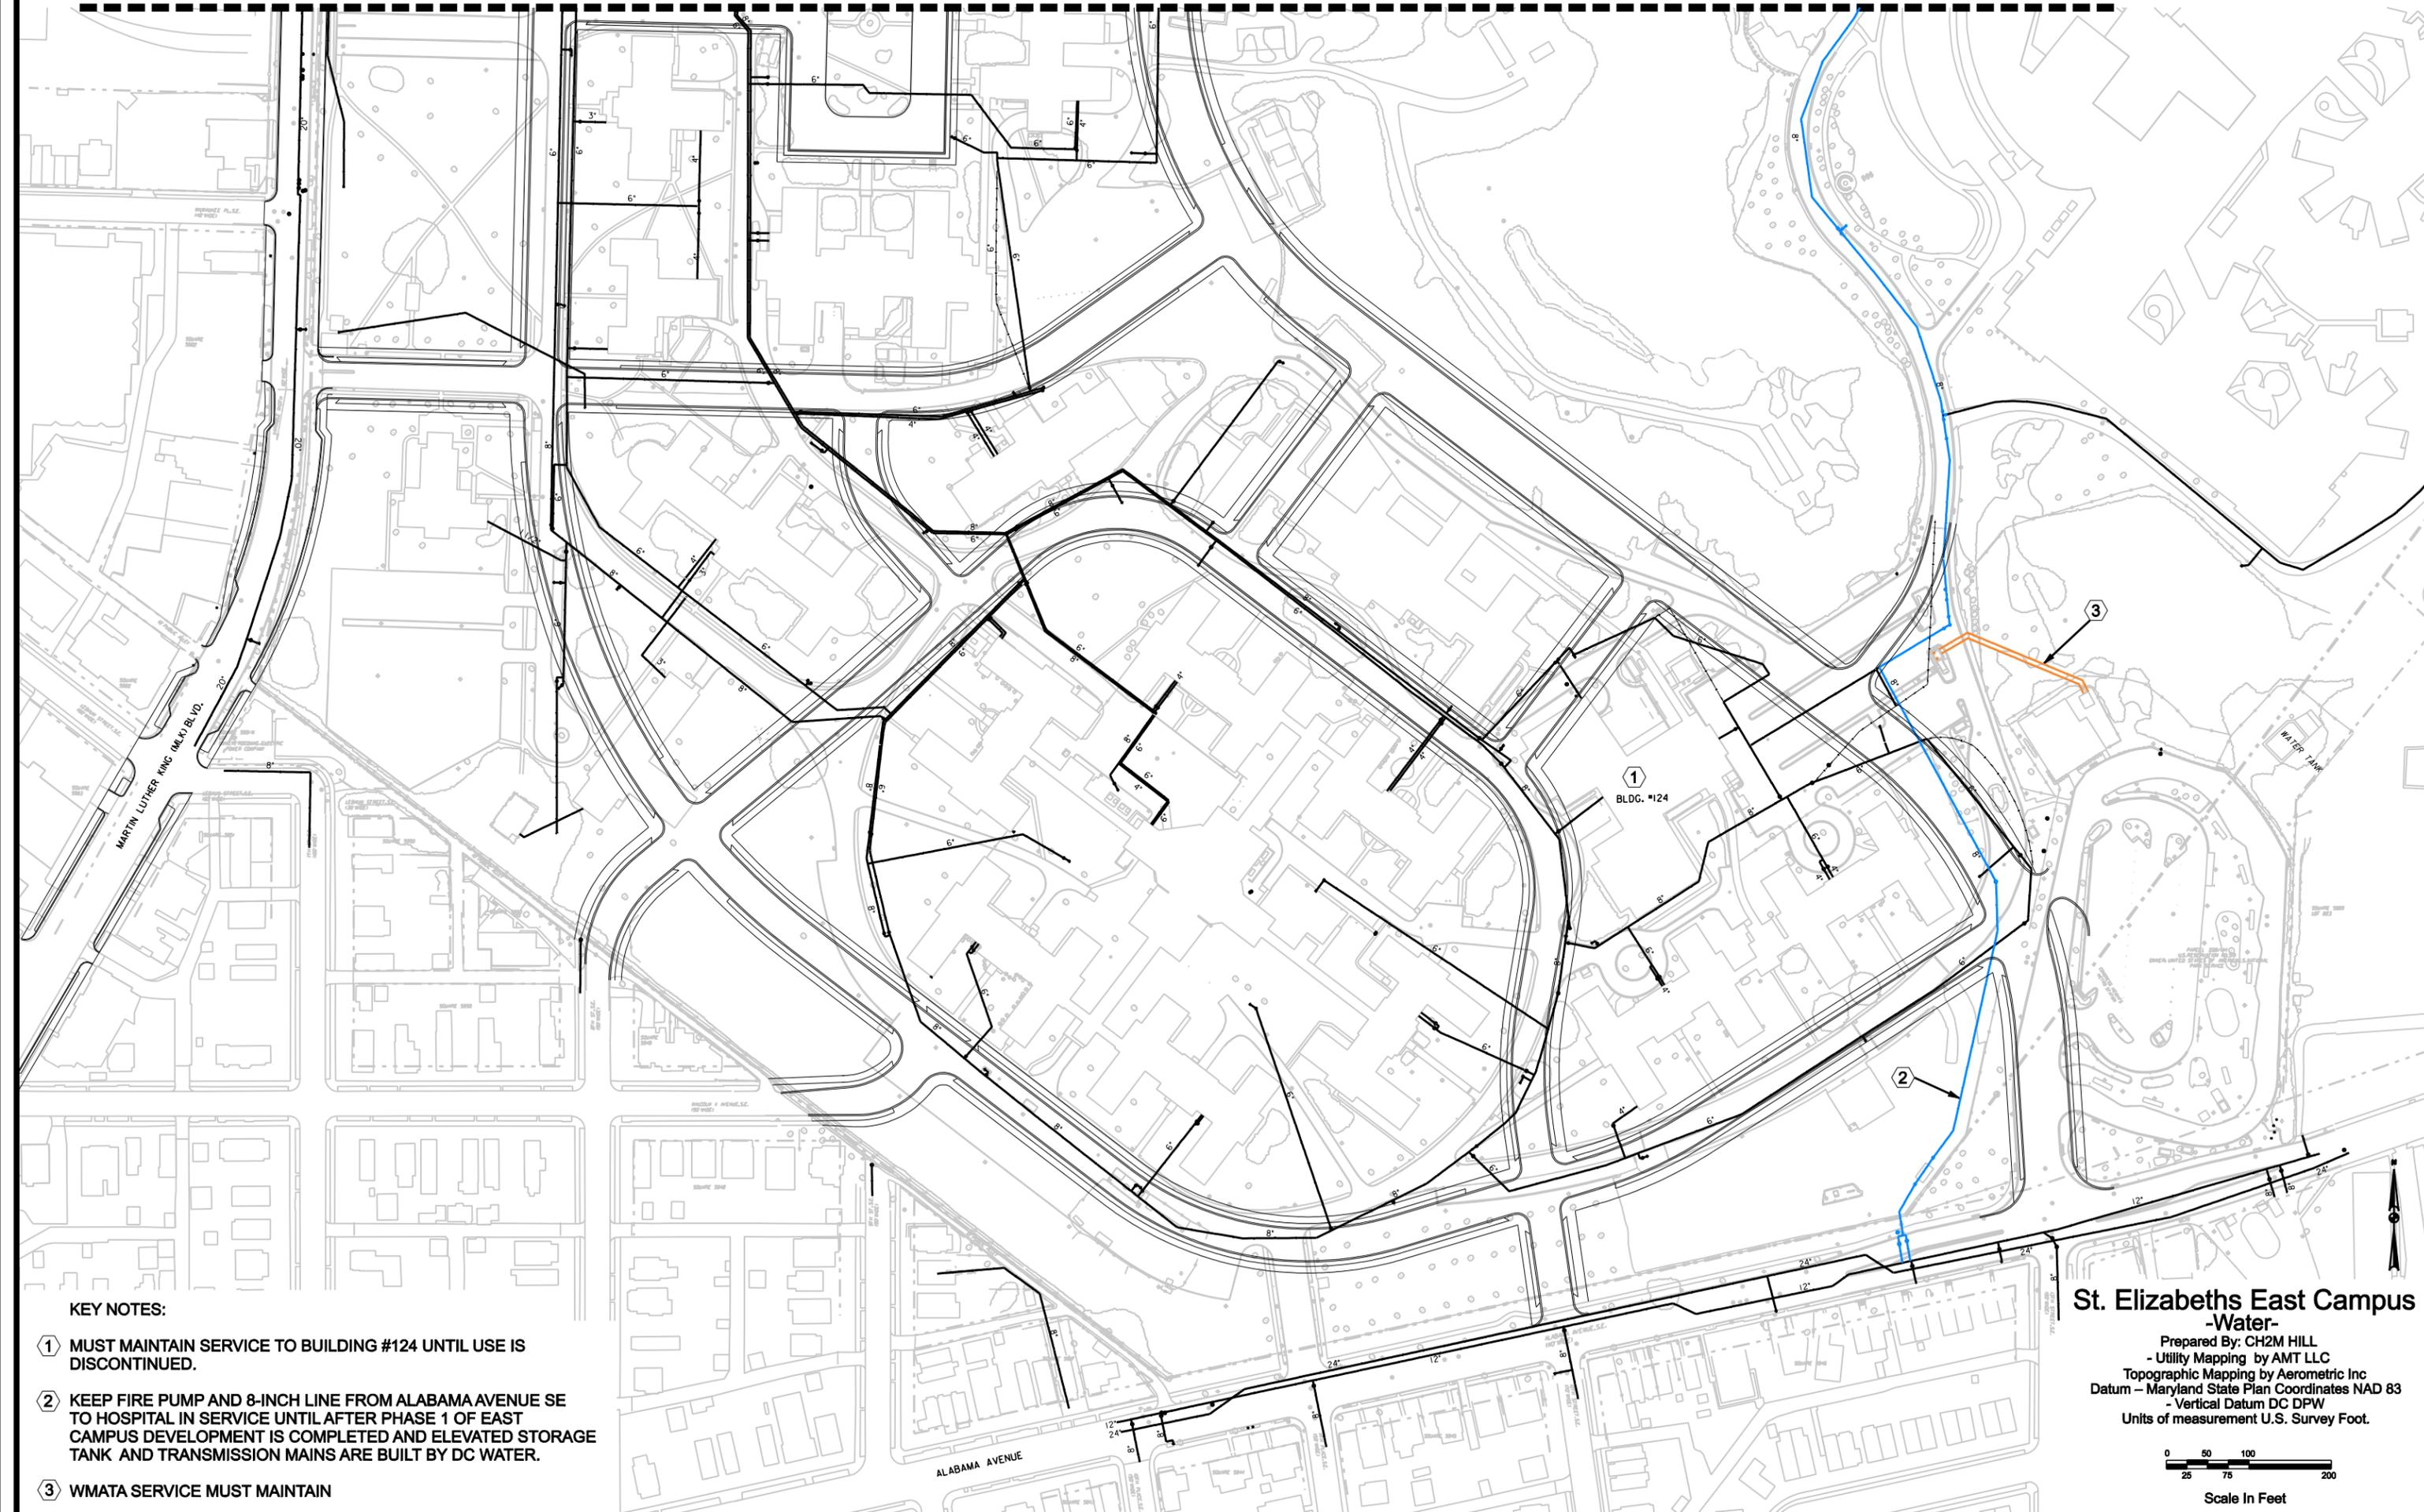
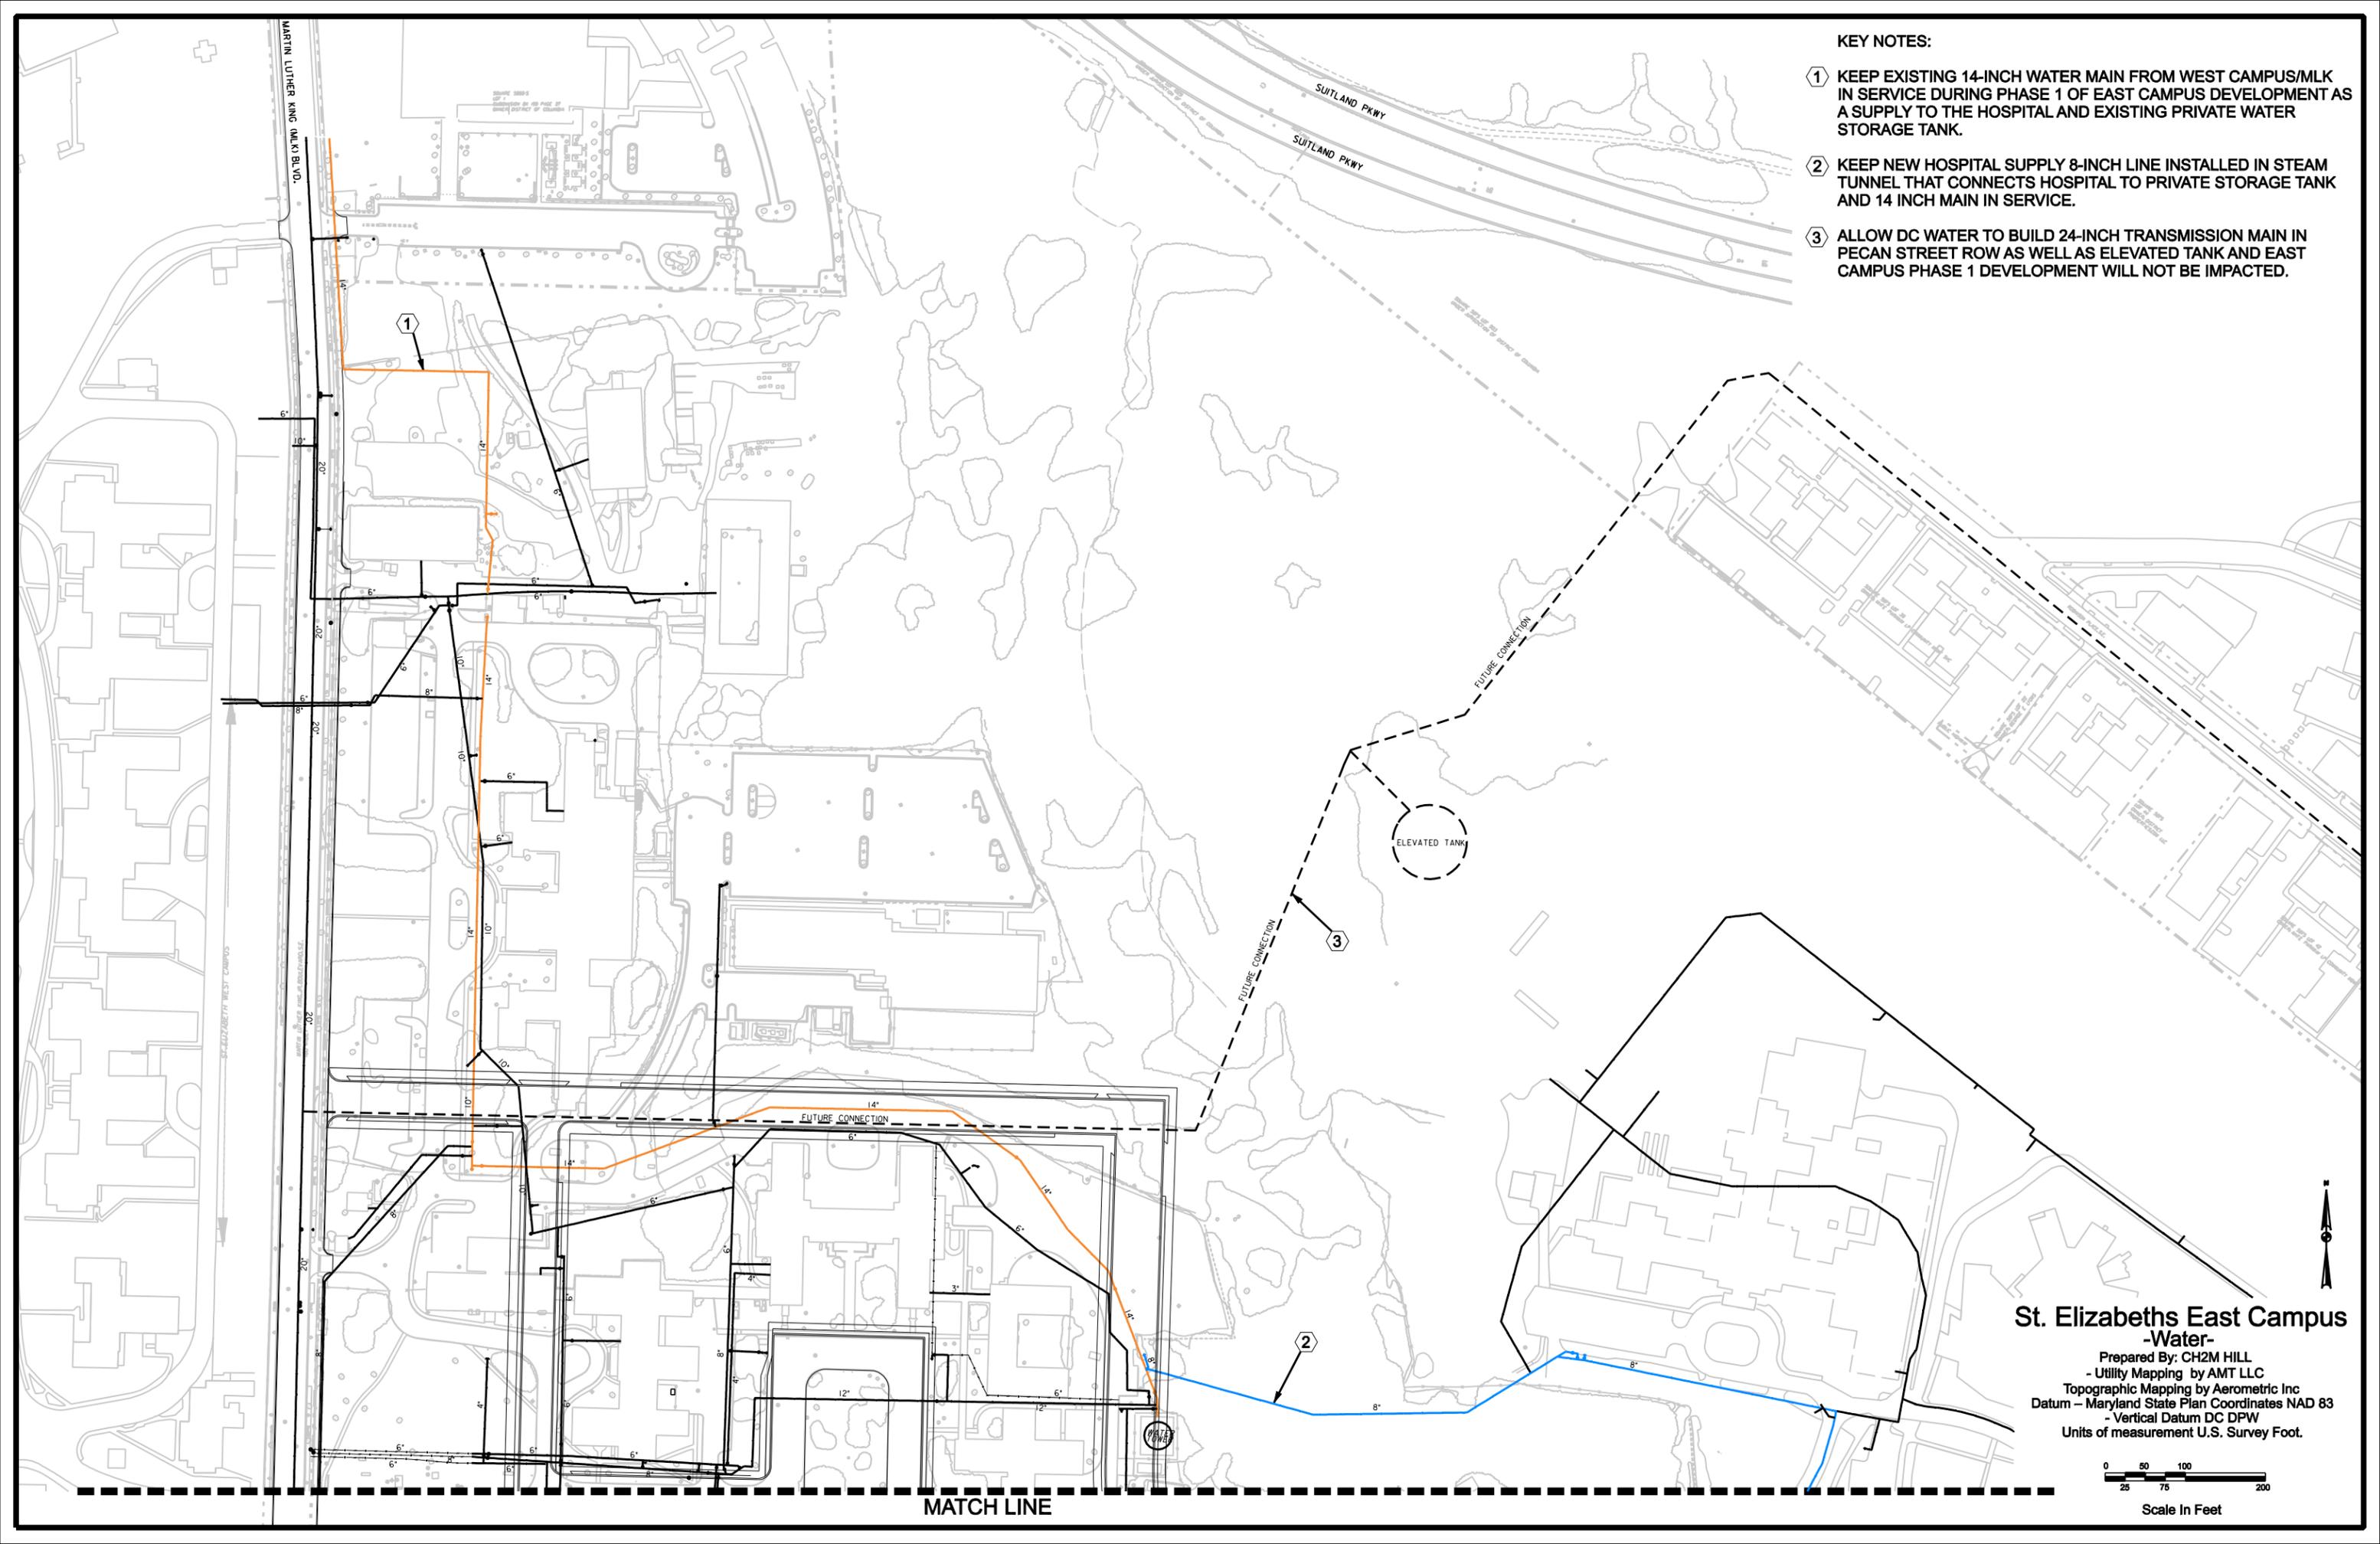
2C
Existing Facilities Exhibits

- ① MUST MAINTAIN SERVICE TO BUILDING #124 UNTIL USE IS DISCONTINUED.
- ② KEEP FIRE PUMP AND 8-INCH LINE FROM ALABAMA AVENUE SE TO HOSPITAL IN SERVICE UNTIL AFTER PHASE 1 OF EAST CAMPUS DEVELOPMENT IS COMPLETED AND ELEVATED STORAGE TANK AND TRANSMISSION MAINS ARE BUILT BY DC WATER.
- ③ WMATA SERVICE MUST MAINTAIN

- ① KEEP EXISTING 14-INCH WATER MAIN FROM WEST CAMPUS/MLK IN SERVICE DURING PHASE 1 OF EAST CAMPUS DEVELOPMENT AS A SUPPLY TO THE HOSPITAL AND EXISTING PRIVATE WATER STORAGE TANK.
- ② KEEP NEW HOSPITAL SUPPLY 8-INCH LINE INSTALLED IN STEAM TUNNEL THAT CONNECTS HOSPITAL TO PRIVATE STORAGE TANK AND 14 INCH MAIN IN SERVICE.
- ③ ALLOW DC WATER TO BUILD 24-INCH TRANSMISSION MAIN IN PECAN STREET ROW AS WELL AS ELEVATED TANK AND EAST CAMPUS PHASE 1 DEVELOPMENT WILL NOT BE IMPACTED.

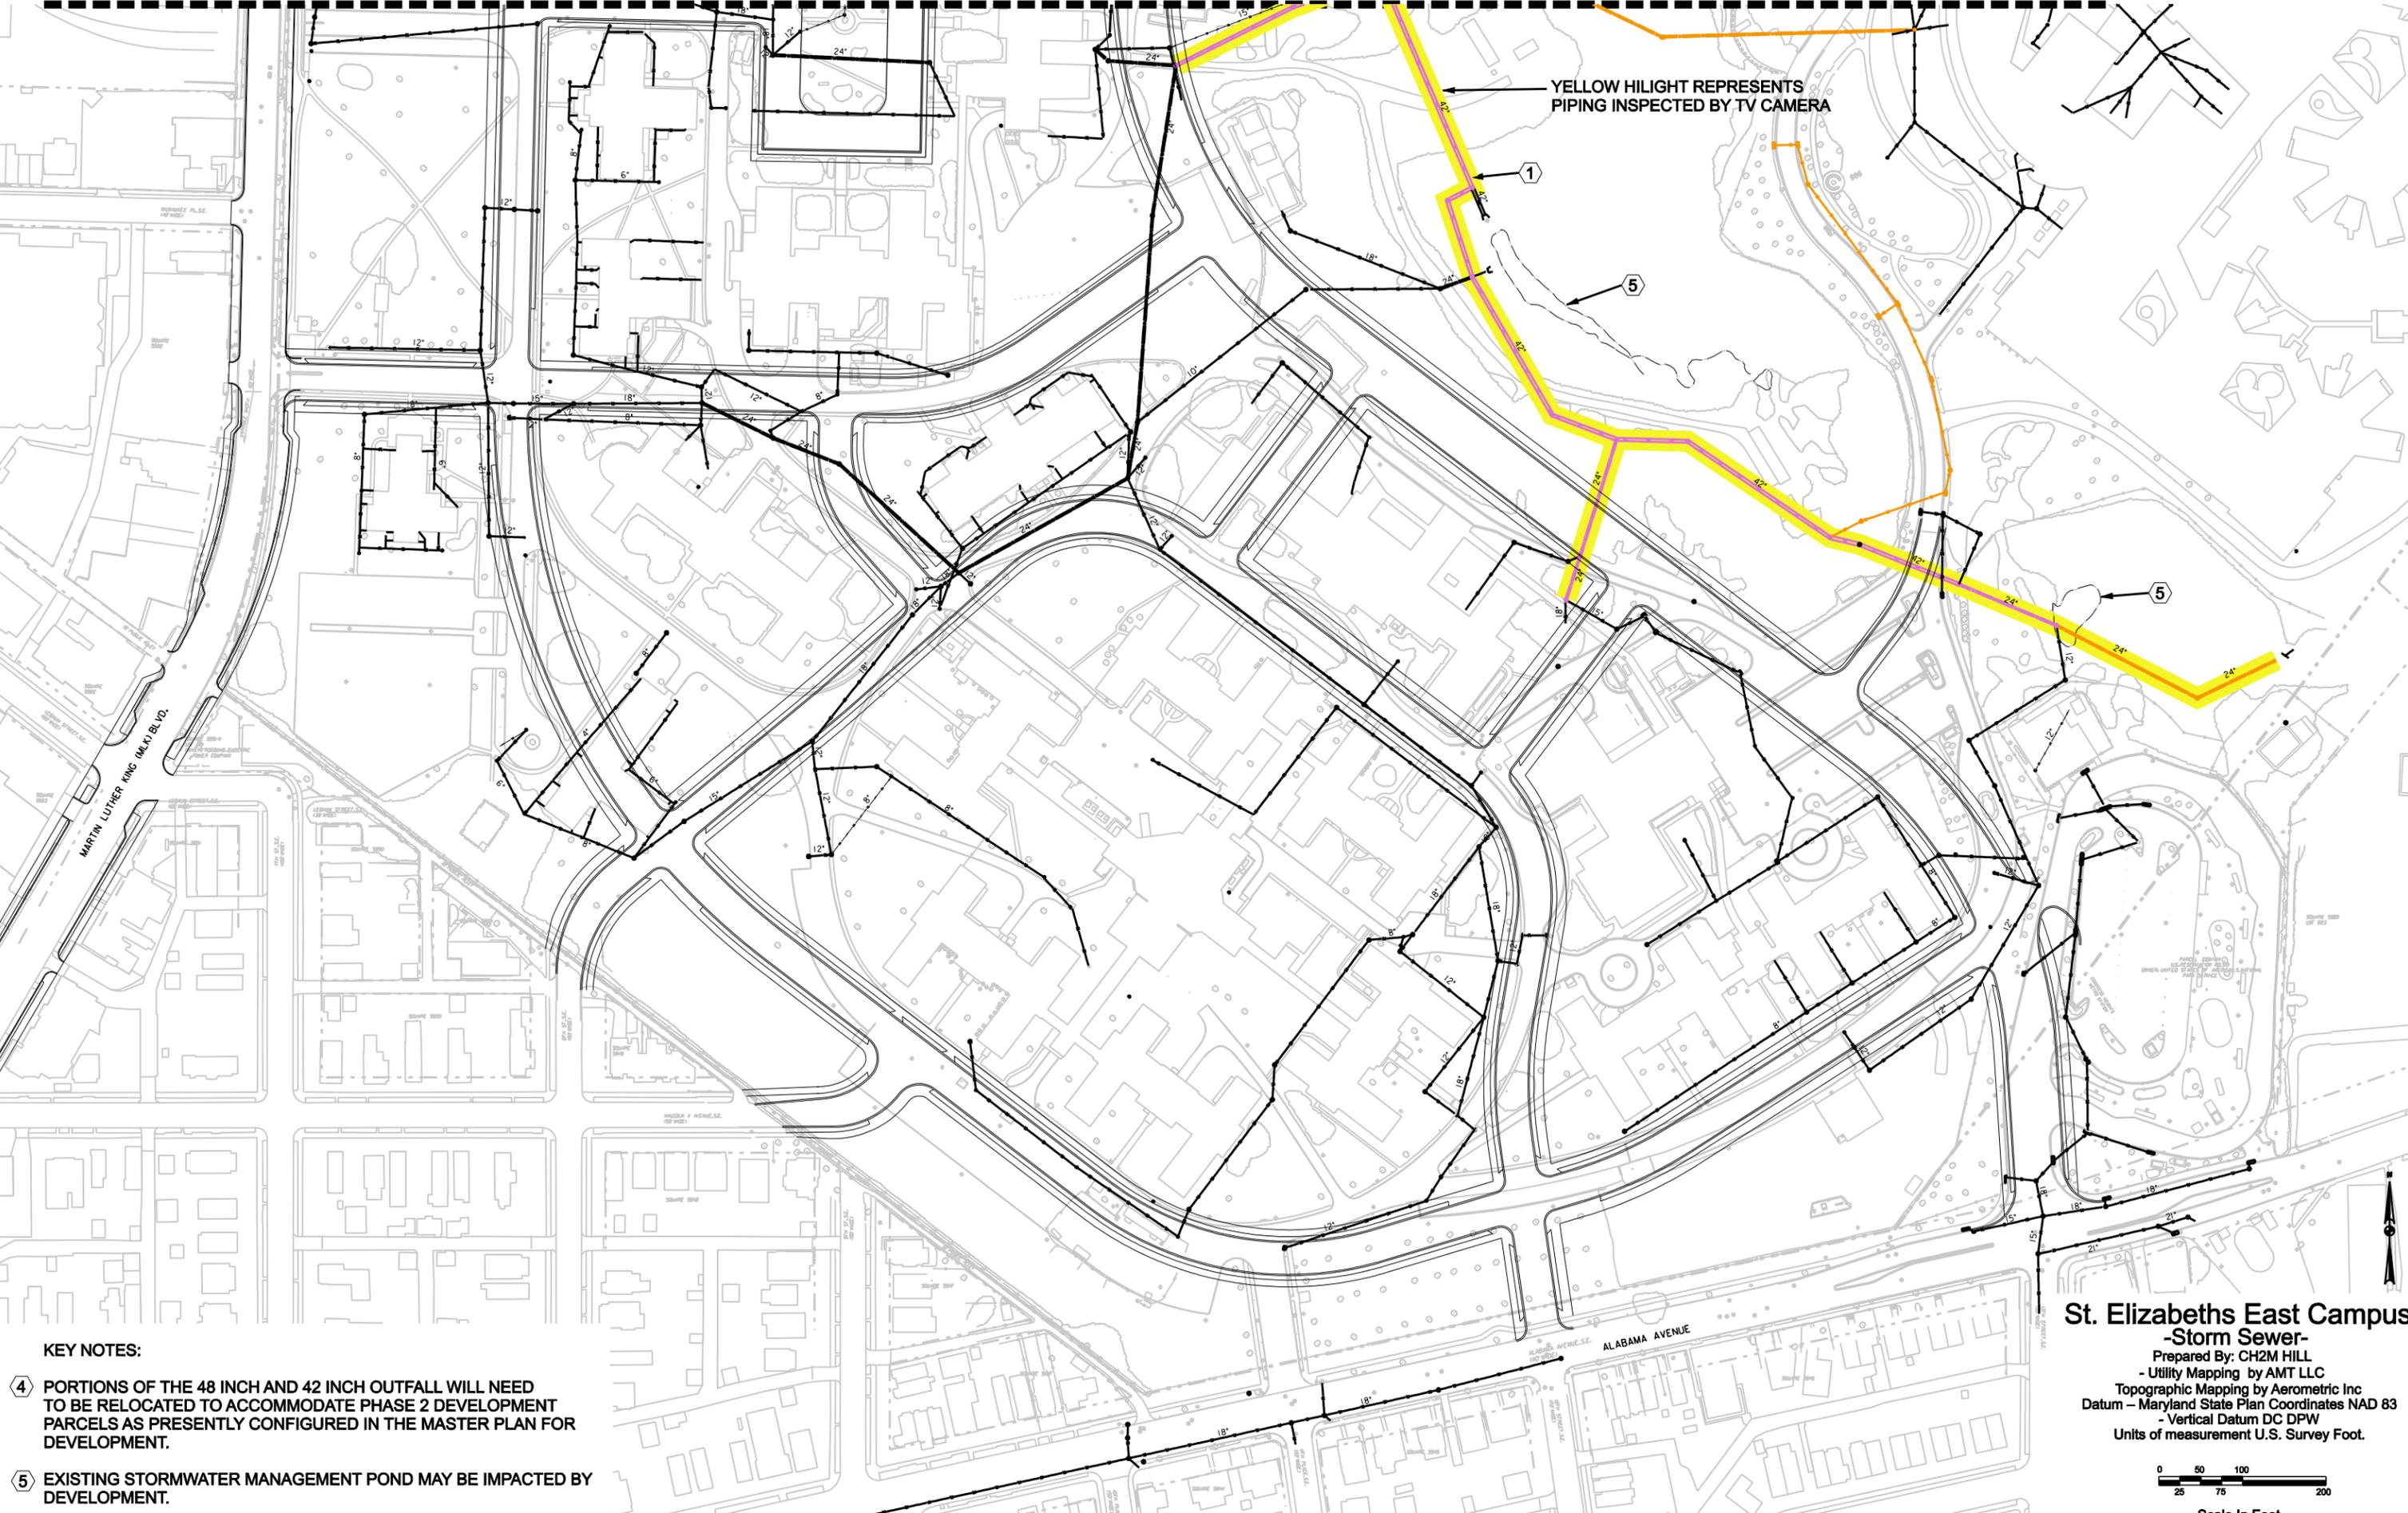
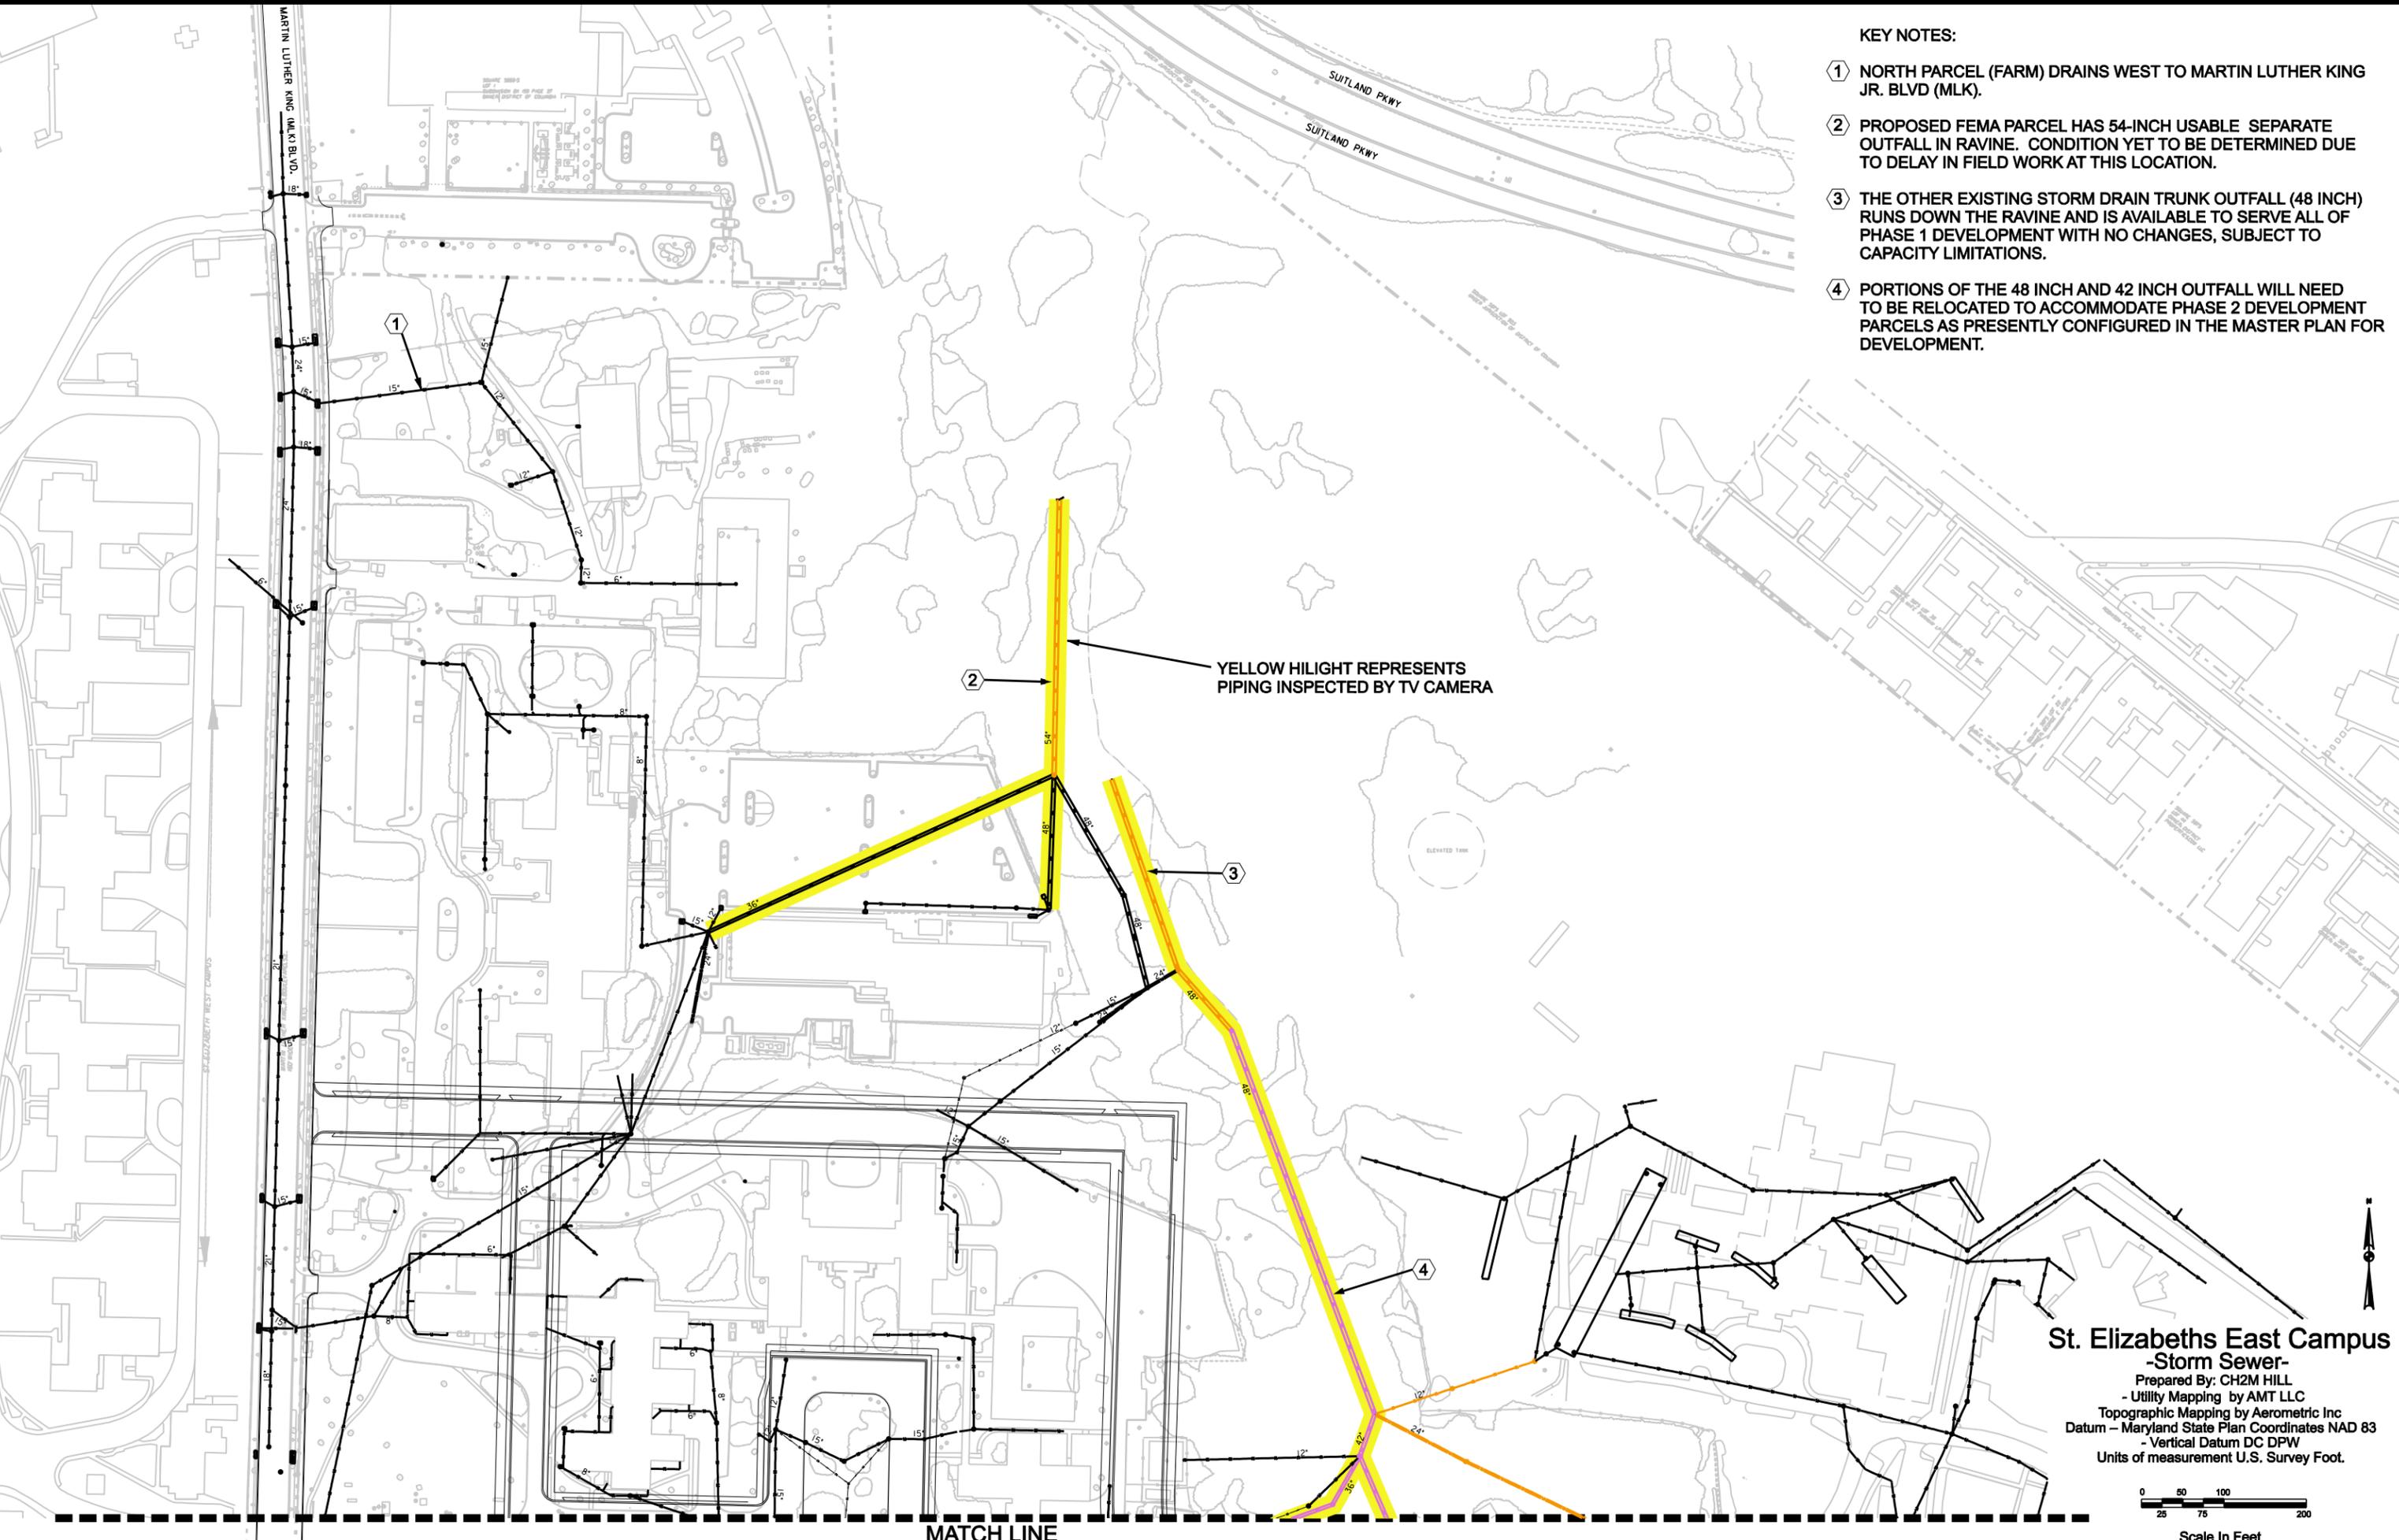
- ④ PORTIONS OF THE 48 INCH AND 42 INCH OUTFALL WILL NEED TO BE RELOCATED TO ACCOMMODATE PHASE 2 DEVELOPMENT PARCELS AS PRESENTLY CONFIGURED IN THE MASTER PLAN FOR DEVELOPMENT.
- ⑤ EXISTING STORMWATER MANAGEMENT POND MAY BE IMPACTED BY DEVELOPMENT.

- ① NORTH PARCEL (FARM) DRAINS WEST TO MARTIN LUTHER KING JR. BLVD (MLK).
- ② PROPOSED FEMA PARCEL HAS 54-INCH USABLE SEPARATE OUTFALL IN RAVINE. CONDITION YET TO BE DETERMINED DUE TO DELAY IN FIELD WORK AT THIS LOCATION.
- ③ THE OTHER EXISTING STORM DRAIN TRUNK OUTFALL (48 INCH) RUNS DOWN THE RAVINE AND IS AVAILABLE TO SERVE ALL OF PHASE 1 DEVELOPMENT WITH NO CHANGES, SUBJECT TO CAPACITY LIMITATIONS.
- ④ PORTIONS OF THE 48 INCH AND 42 INCH OUTFALL WILL NEED TO BE RELOCATED TO ACCOMMODATE PHASE 2 DEVELOPMENT PARCELS AS PRESENTLY CONFIGURED IN THE MASTER PLAN FOR DEVELOPMENT.

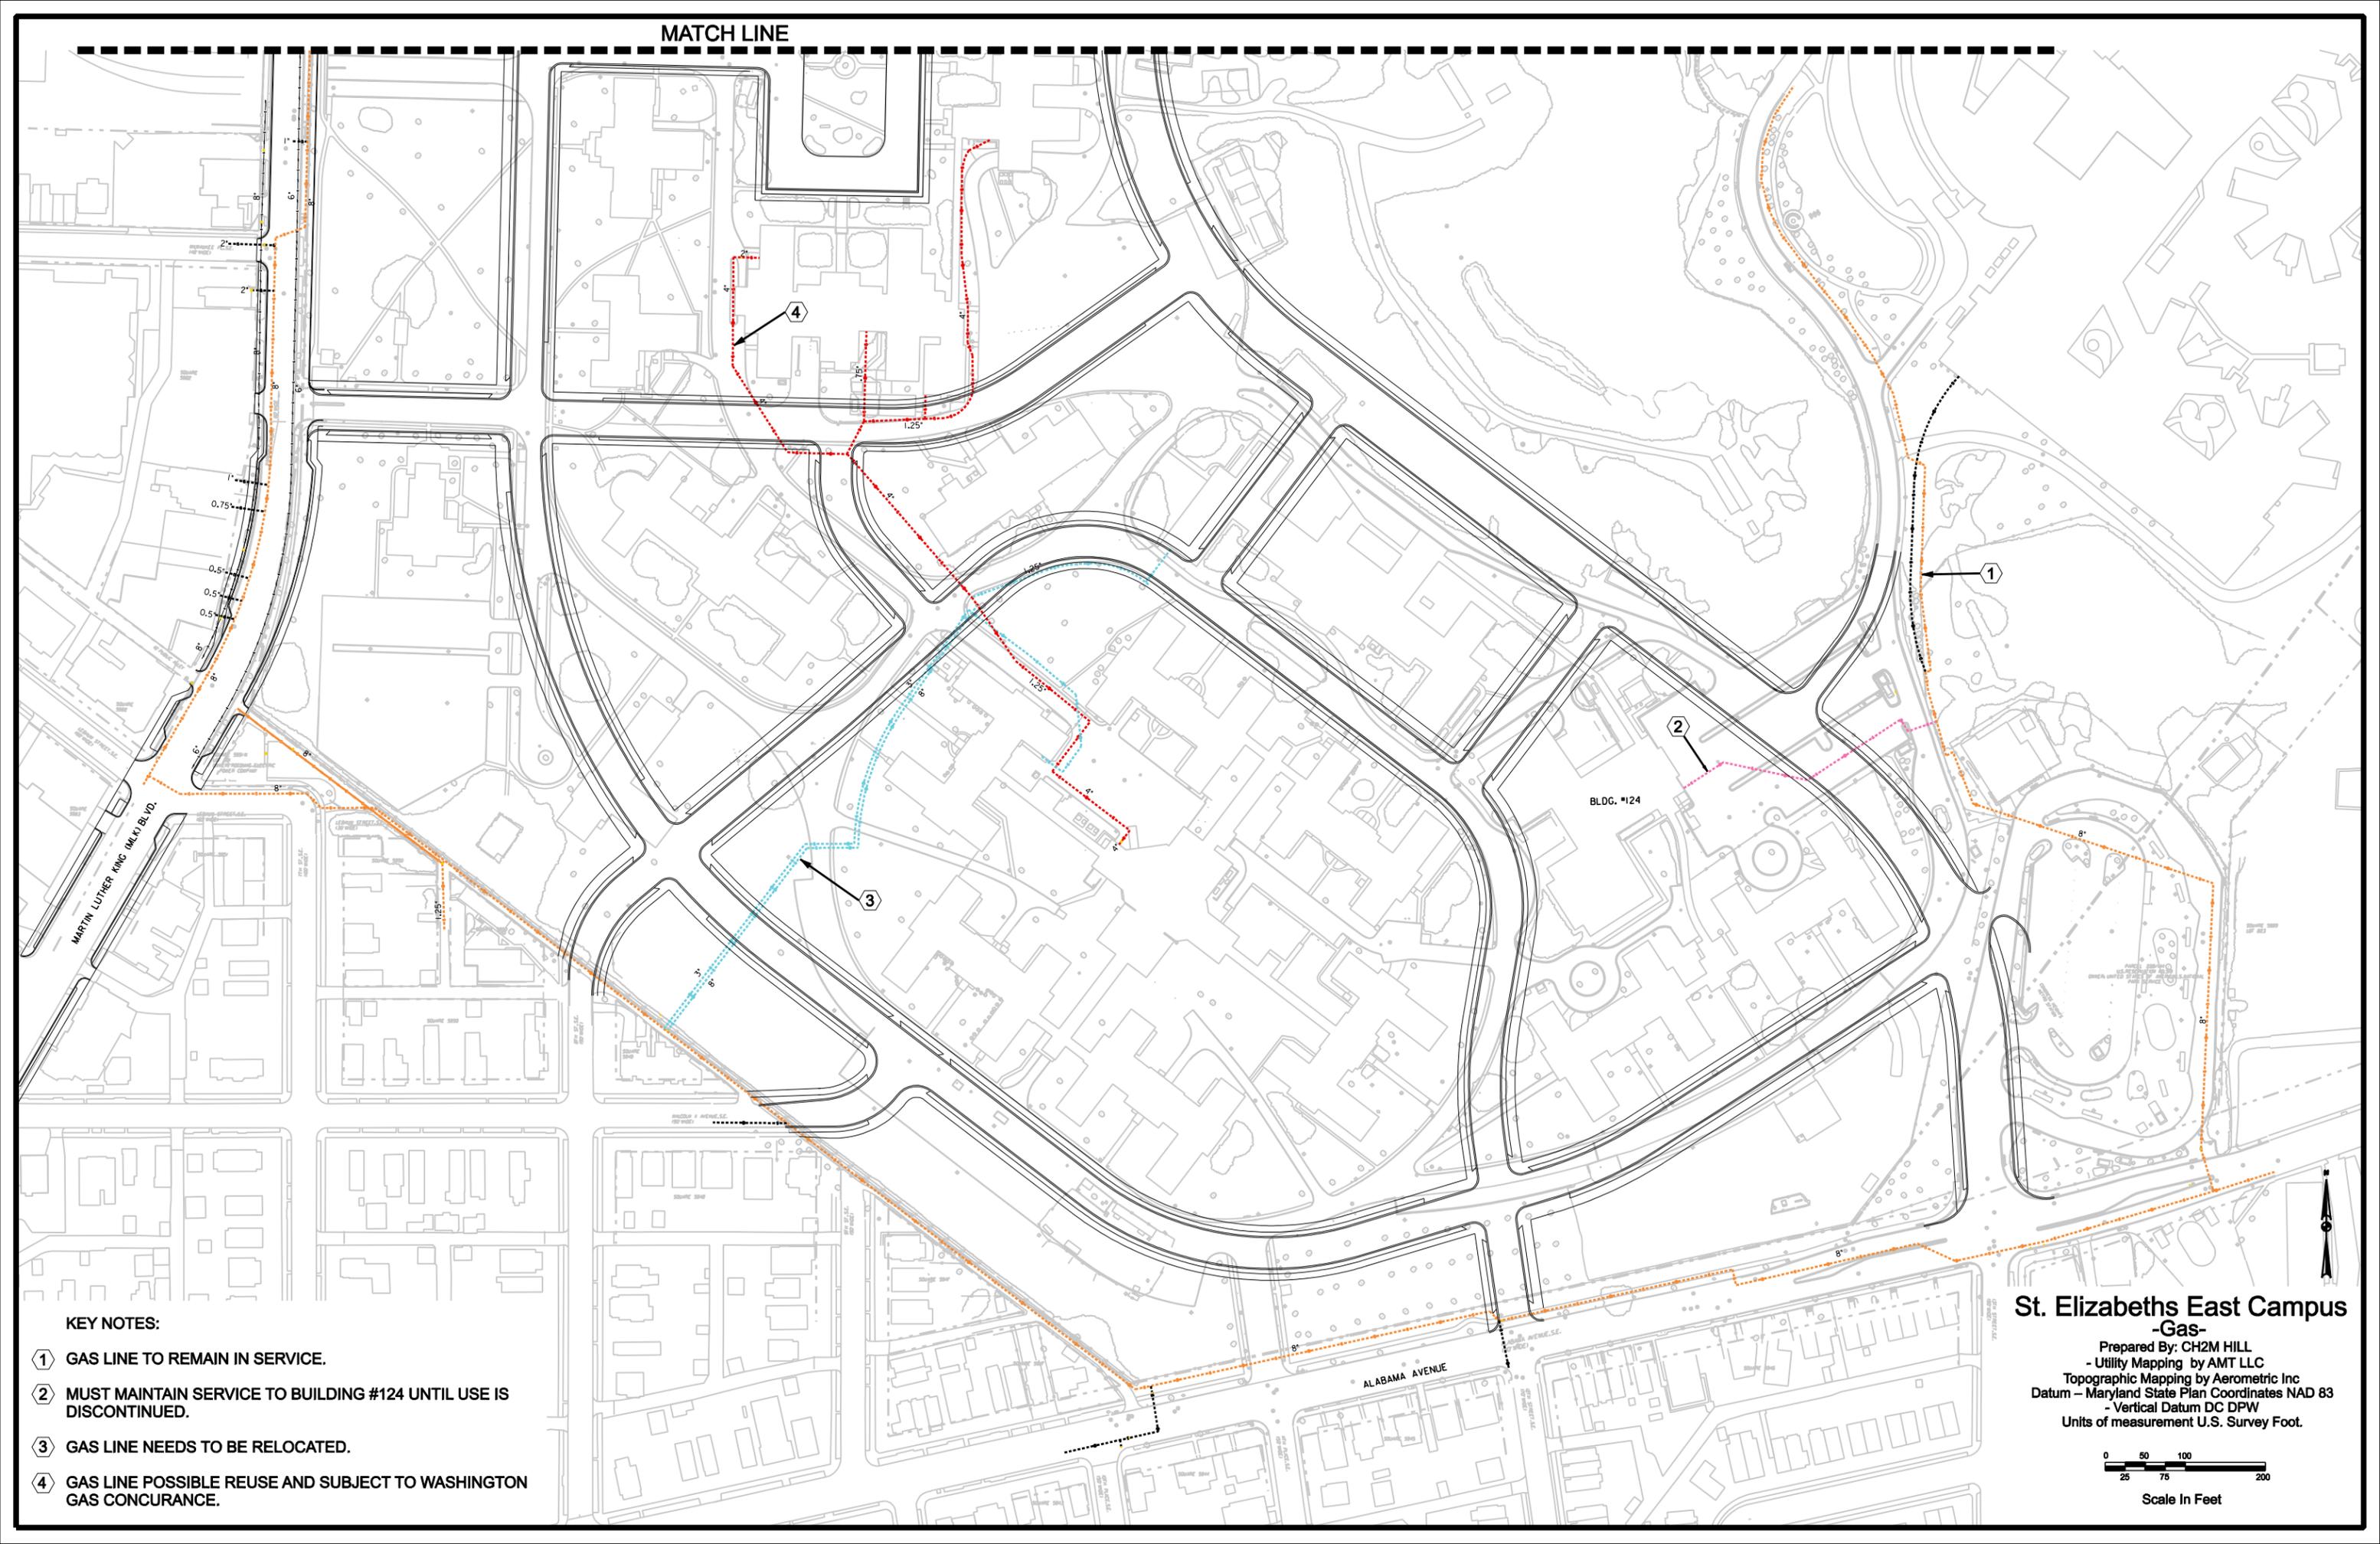
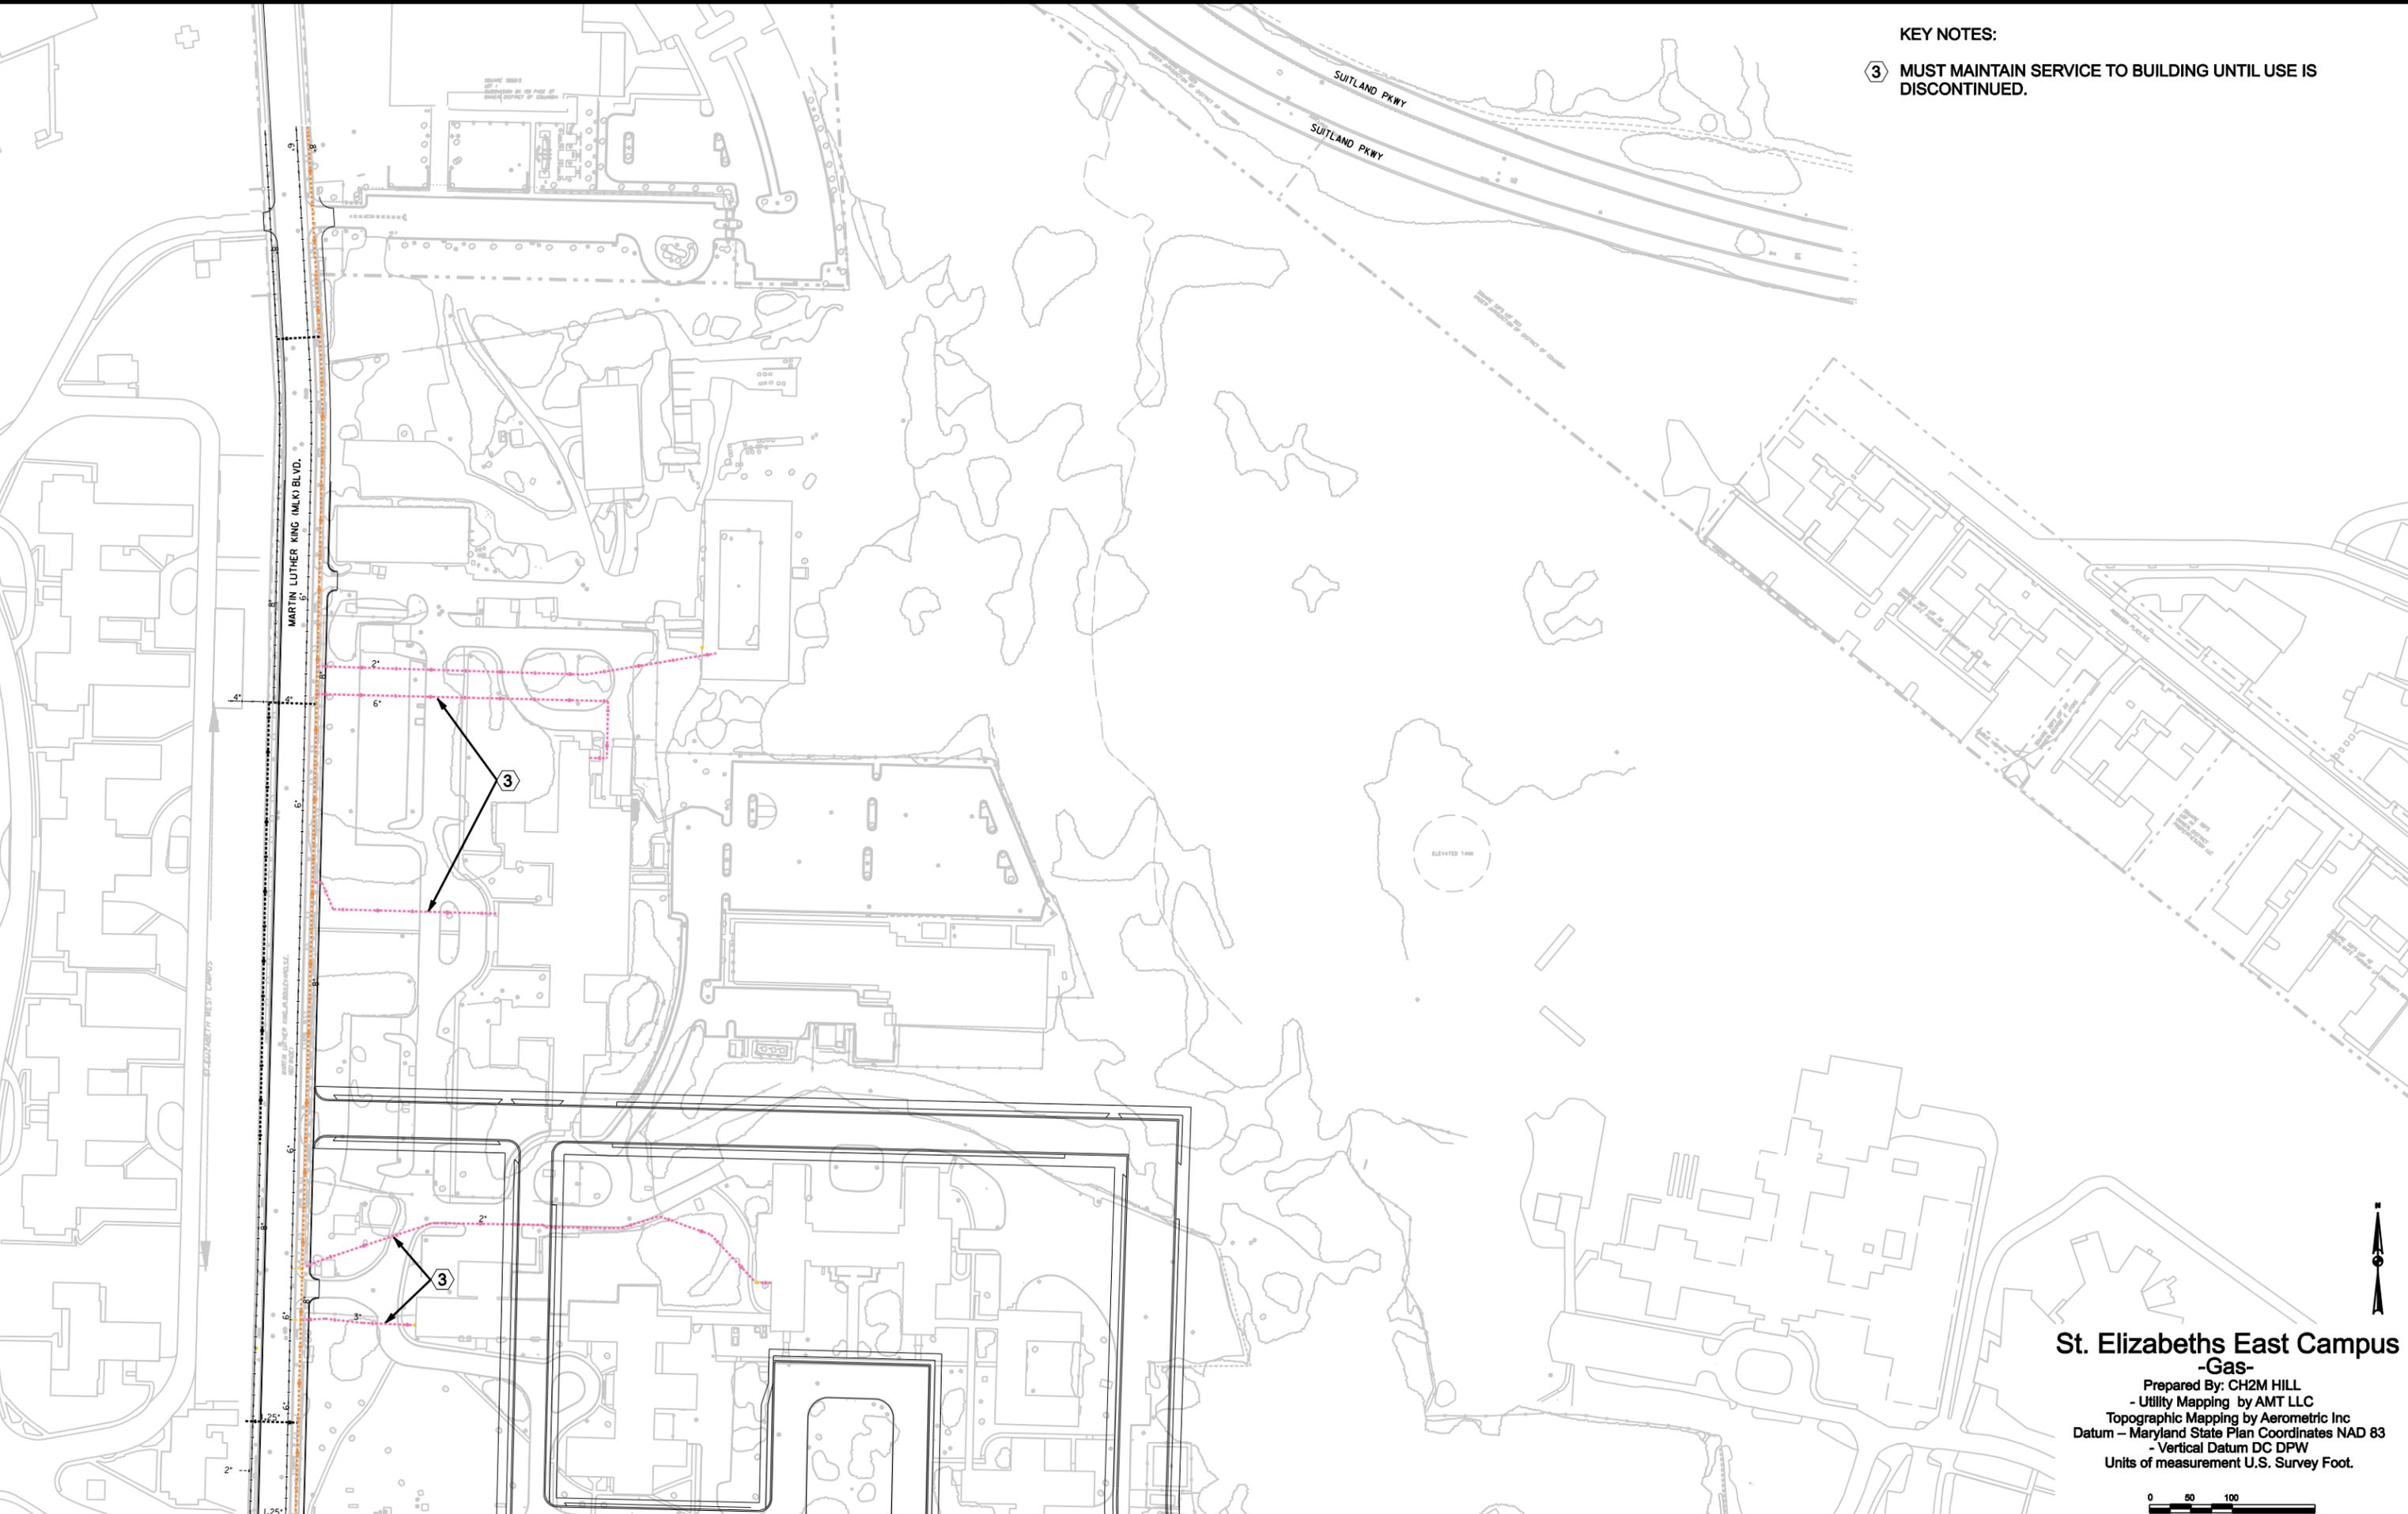
6A
Existing Facilities Exhibits

- ① GAS LINE TO REMAIN IN SERVICE.
- ② MUST MAINTAIN SERVICE TO BUILDING #124 UNTIL USE IS DISCONTINUED.
- ③ GAS LINE NEEDS TO BE RELOCATED.
- ④ GAS LINE POSSIBLE REUSE AND SUBJECT TO WASHINGTON GAS CONCURRENCE.

- ③ MUST MAINTAIN SERVICE TO BUILDING UNTIL USE IS DISCONTINUED.
