St. Elizabeth's East Existing Infrastructure Condition Review Report

Prepared for
District of Columbia
Office of Deputy Mayor
For Planning & Economic Development

January 2012

CH2MHILL®

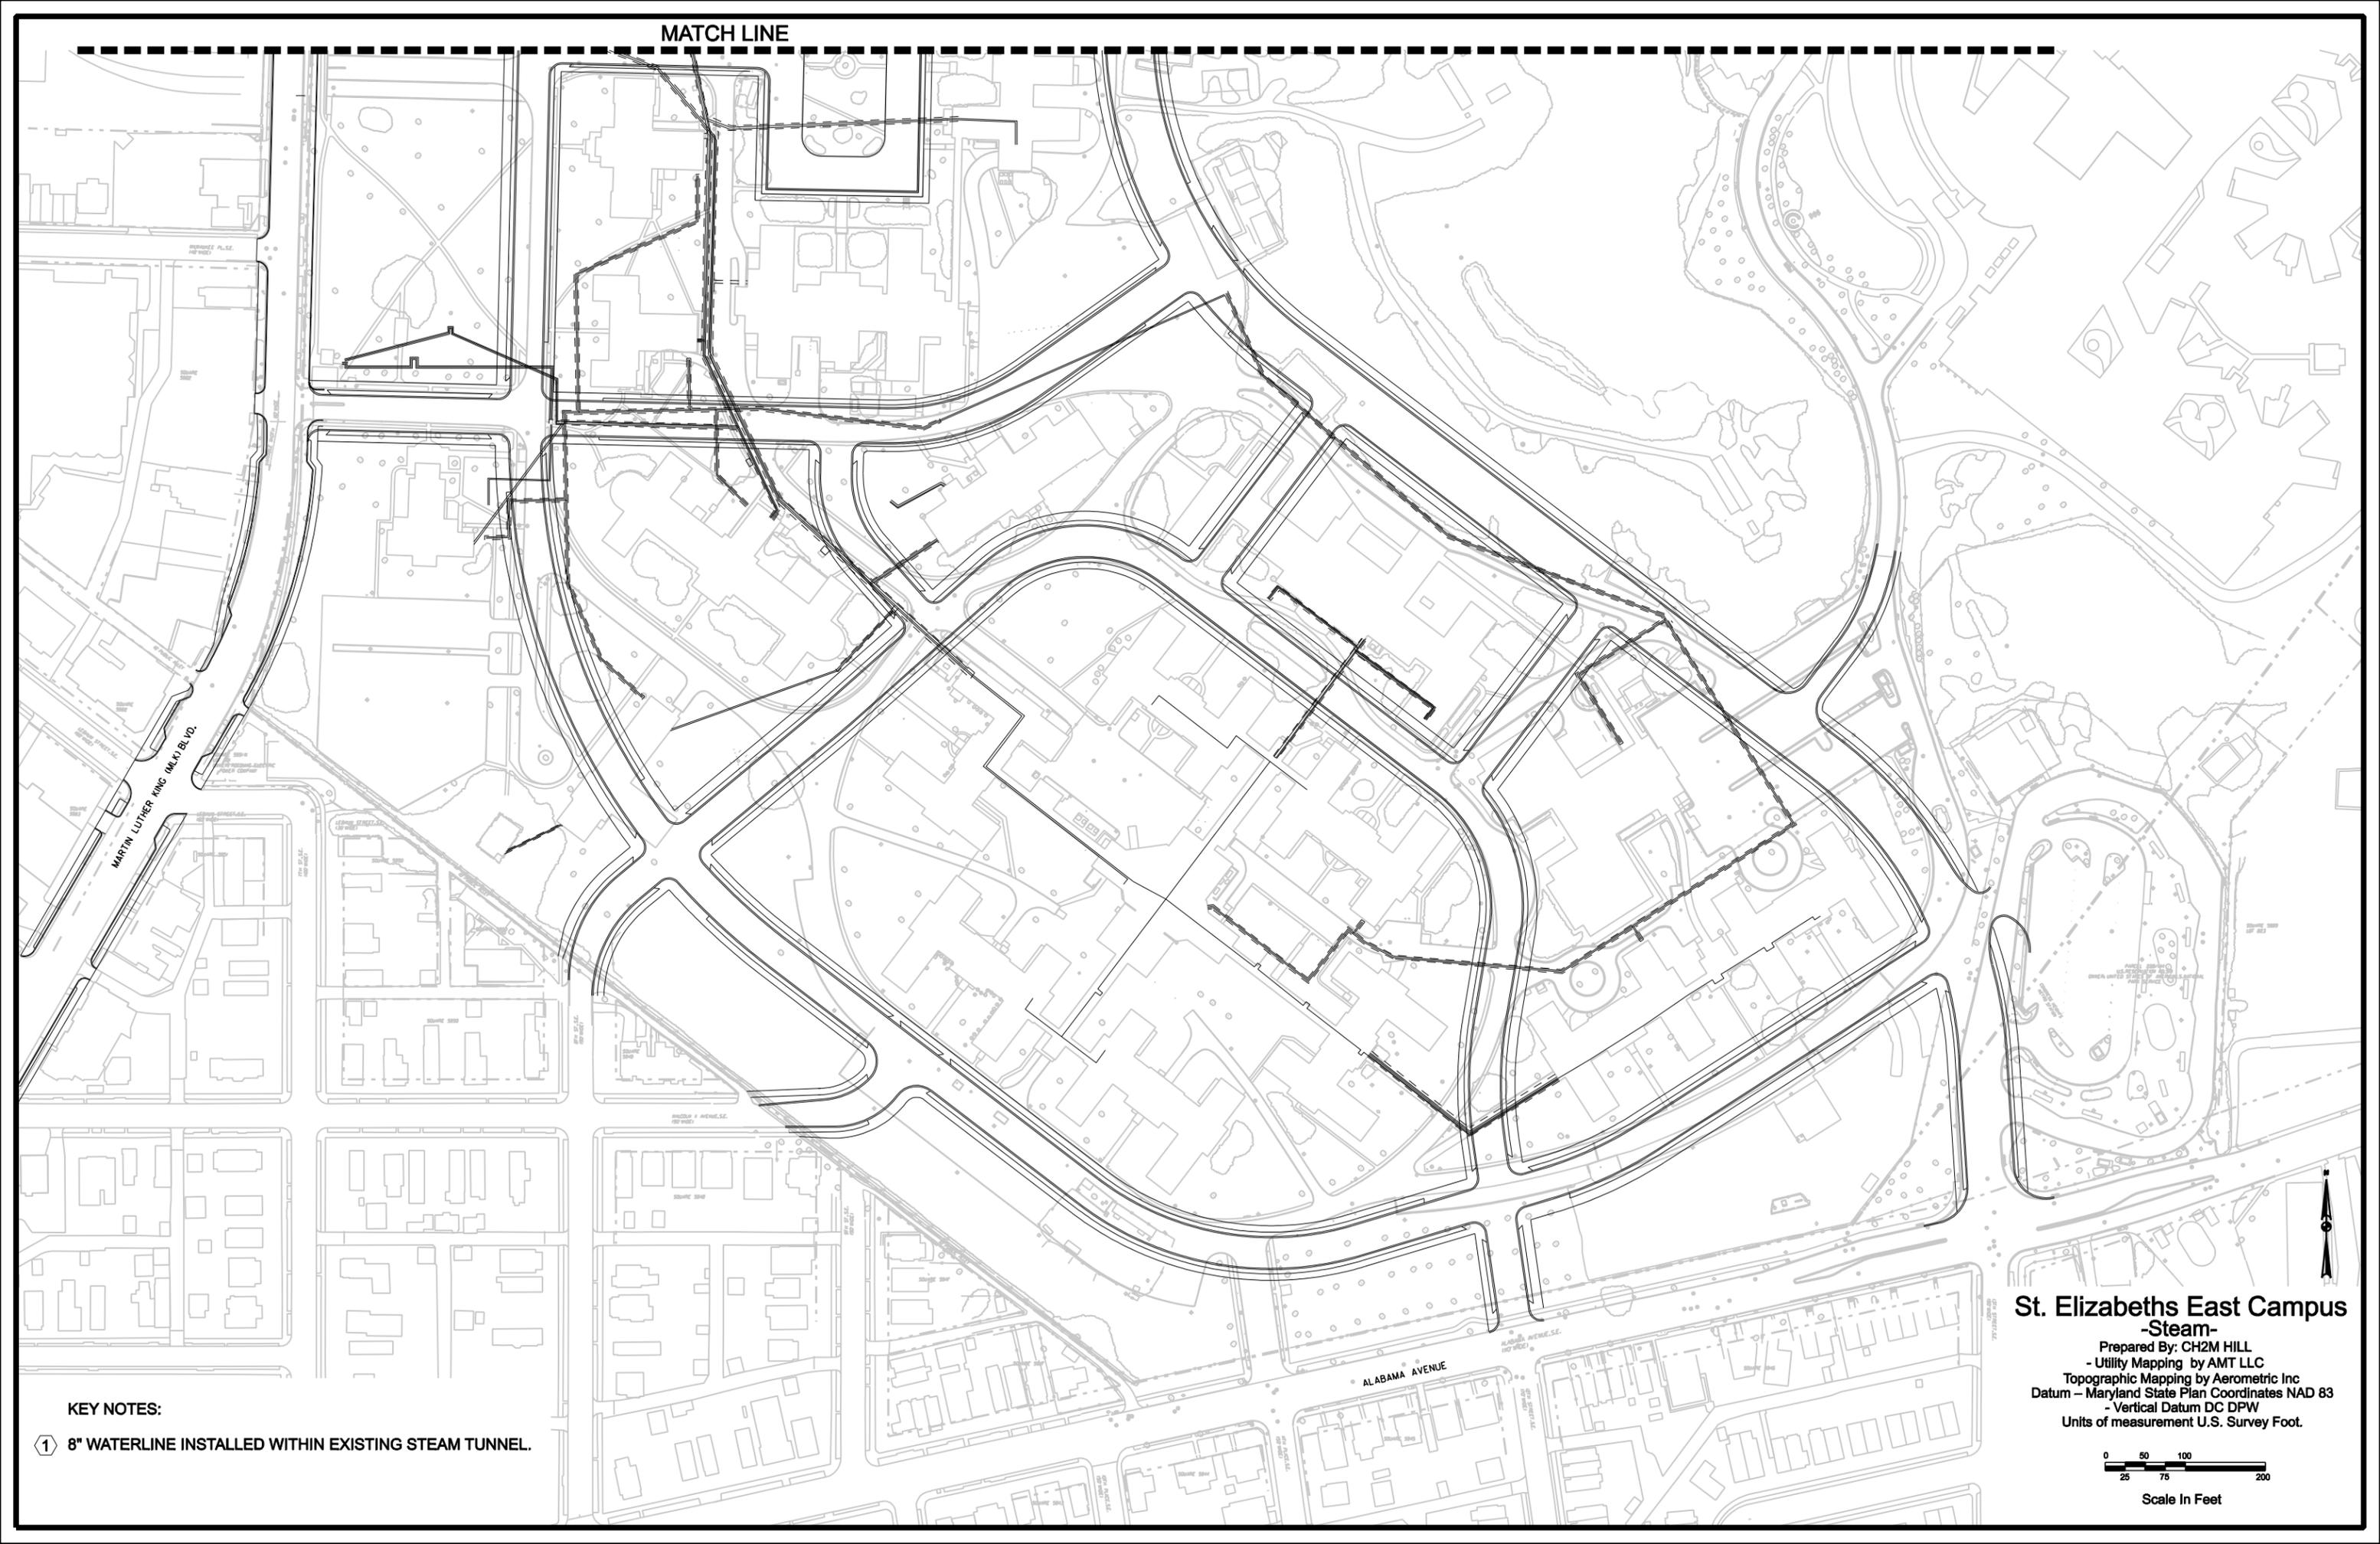
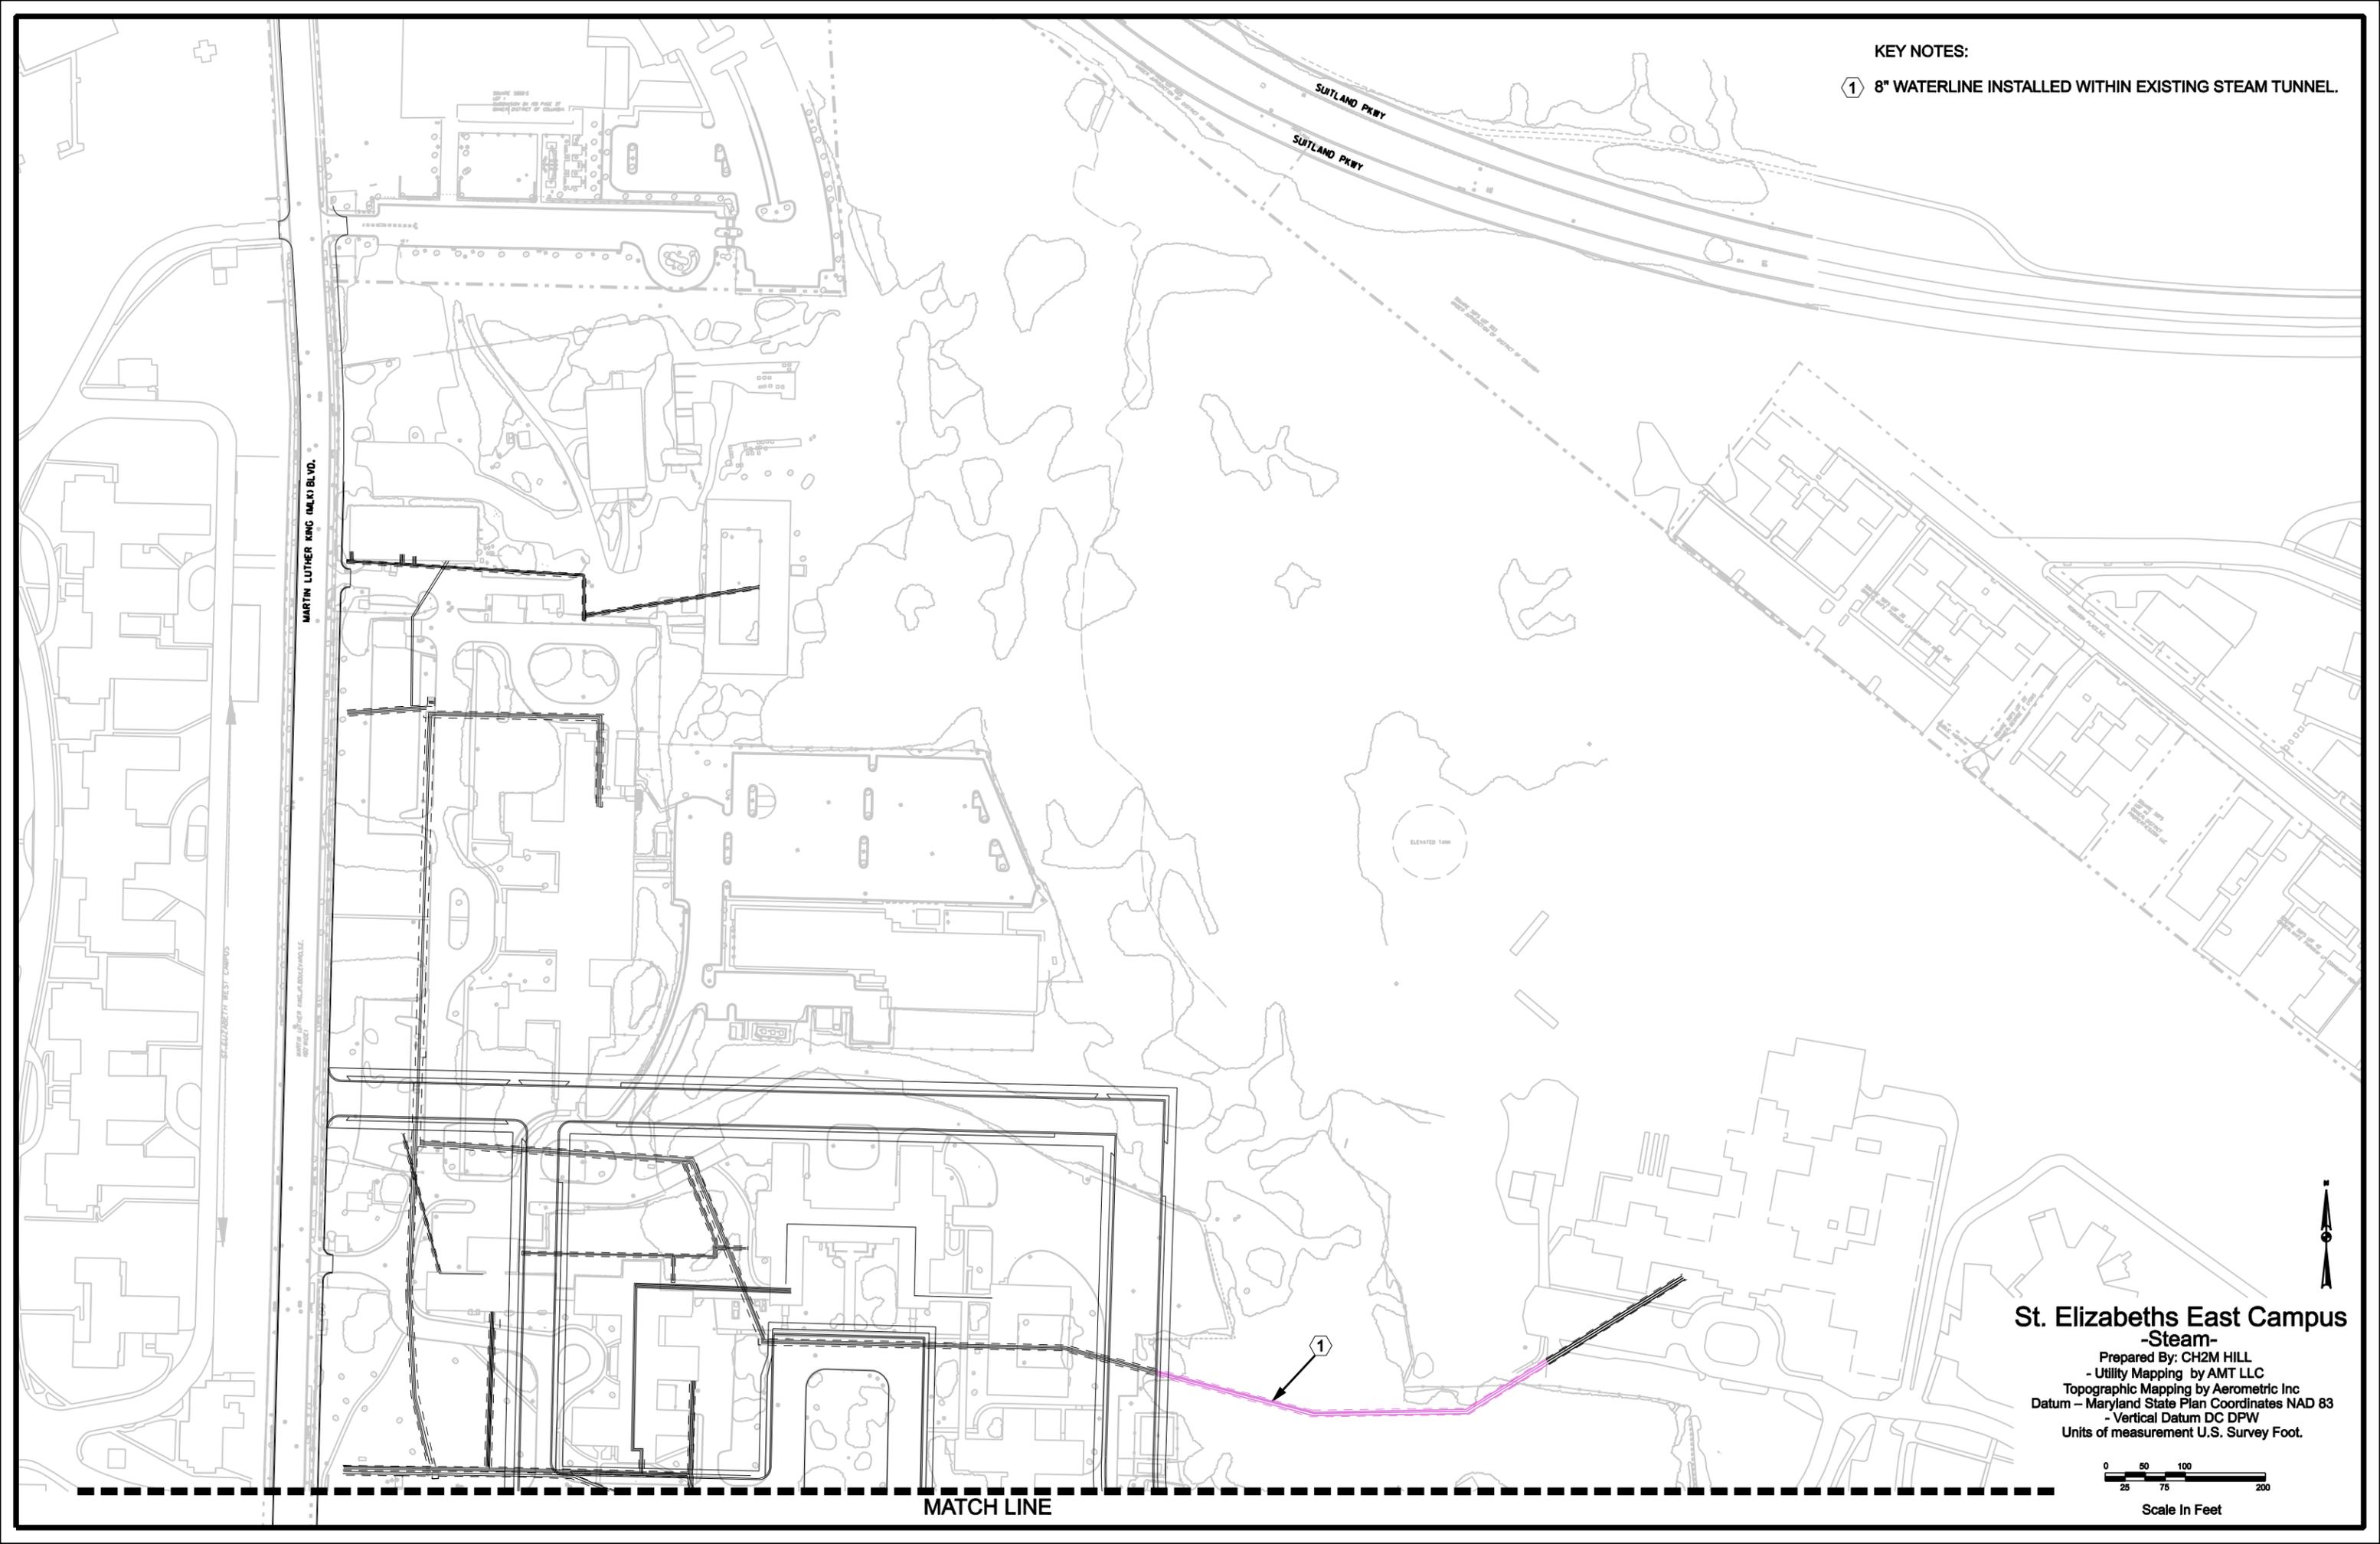
8A
Existing Facilities Exhibits

- ① 8" WATERLINE INSTALLED WITHIN EXISTING STEAM TUNNEL.

① 8" WATERLINE INSTALLED WITHIN EXISTING STEAM TUNNEL.
